The Twelfth East Asia-Pacific Conference on Structural Engineering and Construction

## Behavior of Engineer Constructed Facilities in the Haitian Earthquake of January 12, 2010

P.L. Gould <sup>a</sup>, B.J. Goodno <sup>b</sup>, N.C. Gould <sup>c</sup>, P. Caldwell <sup>d</sup>

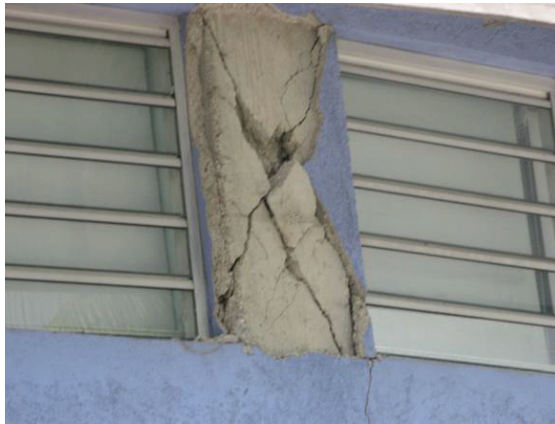
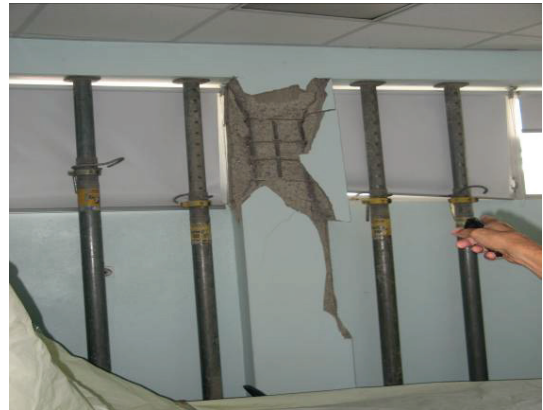
This building is a modern reinforced concrete frame structure with masonry infills. The overall damage was evaluated as moderate. The masonry walls were supposed to be separated from the adjacent columns but this was not always the case. Partial height walls under windows restrained the adjacent columns, which resulted in columns with an effective unrestrained height of the windows, the classical short or captive column effect. This is best understood by the following short derivation.

The column shown in Figure 1 may have developed up to the moment capacities  $M_a$  and  $M_b = M_u$  at both ends. However, the restraint of the walls forces the bending with a reduced length  $L < L_{ab}$ , moving the hinge into a region that was perhaps not detailed for this action. The magnification of the shear force

based on the full length  $L_{ab}$  in Equation (1), apparently caused the column to fail due to inadequate shear reinforcement. The captive columns are being retrofit with steel jackets.

Figure 1: Failure of Captive Column, Exterior and Interior

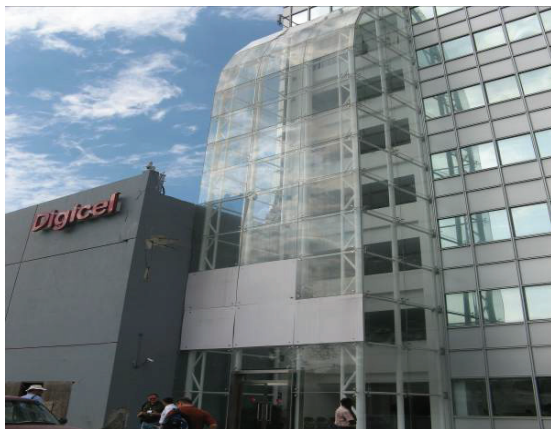
The Digicel tower, on the right in Figure 2, is a 12 story RC dual wall-frame system and is the tallest engineered building in Port-au-Prince. The company provides mobile phone communication, which has been extremely important during the recovery.

Figure 2: Digicel Buildings

The adjacent data center on the left in the photo is a RC moment resistant frame. While the damage was regarded as moderate in the tower, the data center was severely damaged. Moreover, a reinforced concrete frame hospital building with masonry infills directly across the street essentially collapsed (EERI, April, 2010) so the region likely experienced moderate to strong motion. Because of their different heights, the periods of the two Digicel structures and the resulting seismic demands are likely quite different but each of the structures has deficiencies in the details that are revealed in the remaining damage.

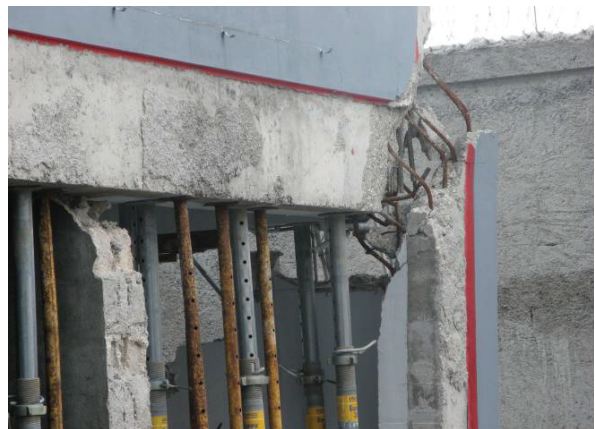
Figure 3: Beam-Column Joint Failure

In the low-rise structure, another type of shear failure was observed in a beam-column joint, as shown in Figure 3. Such a joint needs to transfer the forces from the top reinforcement of the beams that frame into the joint through the joint and into the columns. While the shear strength of such joints is enhanced by the vertical compression from gravity loading and the confinement provided by perpendicular beams framing into the joint, there may still be a need for special horizontal reinforcement through the joint for seismic loading. Such reinforcement is uncommon in conventional construction and is absent from the joint shown in Figure 3. Closely related is the failure shown in Figure 4, where the opening is close to the edge of a shear wall with an inadequately reinforced boundary element.

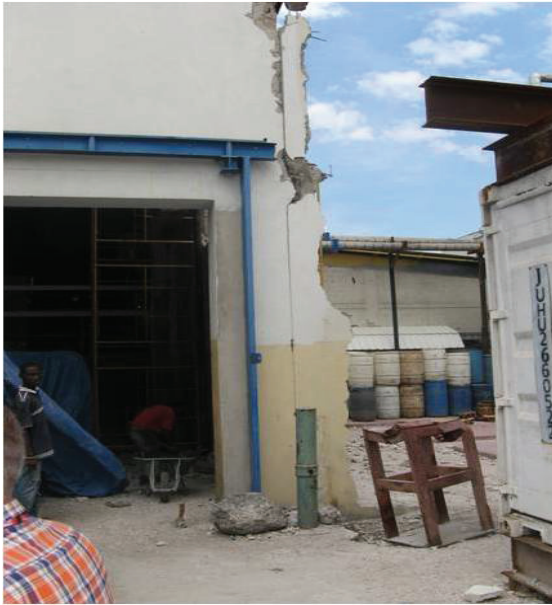
Figure 4: Interrupted Shear Wall

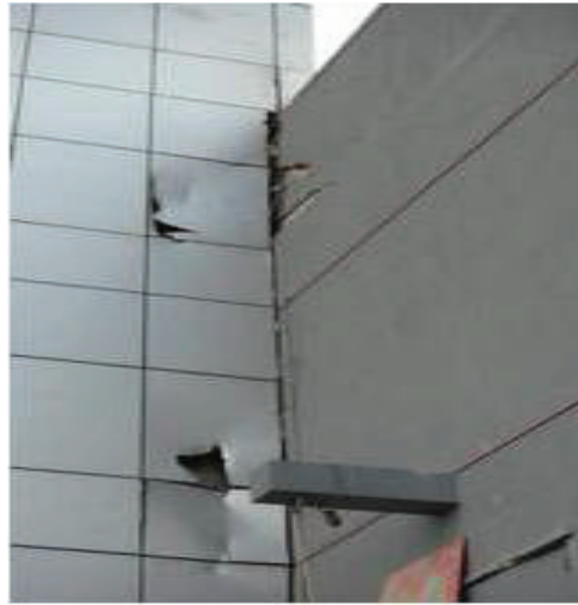
A classical failure observed in this structure is the damage produced by the adjacent low-rise impacting the lower floors of the high-rise. This is known as pounding, as shown in Figure 5.

Figure 5: Pounding Failure

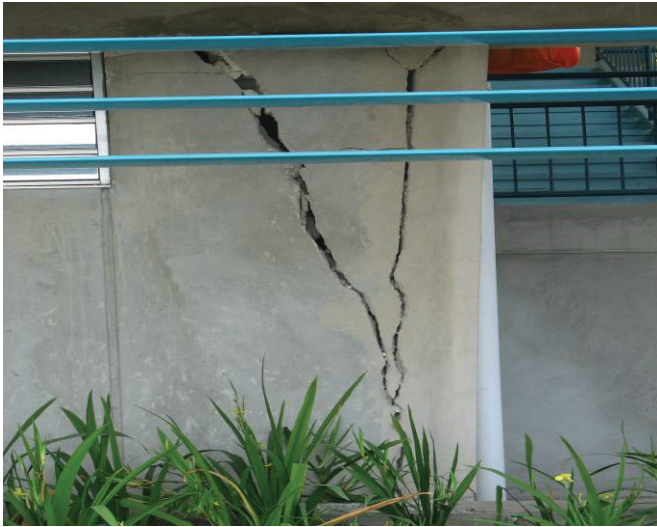
In this building, there is also short column damage as previously described for the CDTI Hospital. Also there are a number of wall failures due to shear-induced diagonal tension, as shown in Figure 6.

Figure 6: Wall failure due to Diagonal Tension

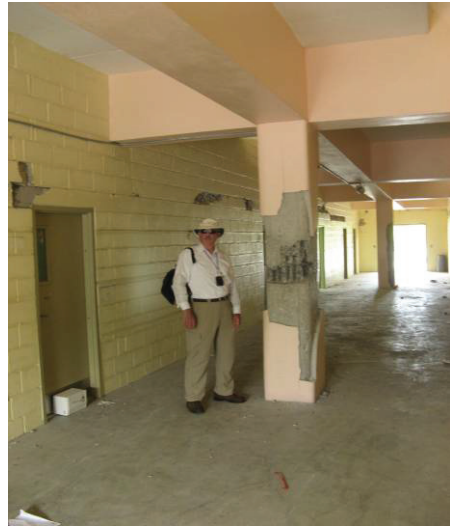
Figure 7: Column Failure at Mid-Height

An interesting column failure is shown in Figure 7. The failure occurred in the mid-height region of the column, apparently because the transverse reinforcement spacing was larger in this region relative to the transverse spacing at the ends of the column (Eberhard, et al, 2010). In addition, it was observed that there was also a lap splice for the vertical reinforcing steel located in this region, as shown on Figure 8.

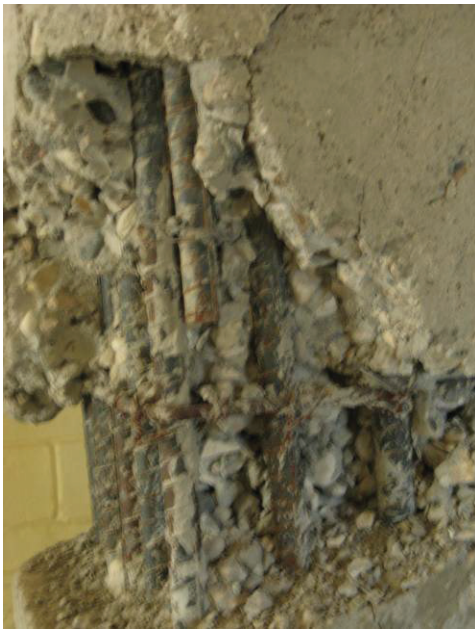
Figure 8: Close-up of failure zone

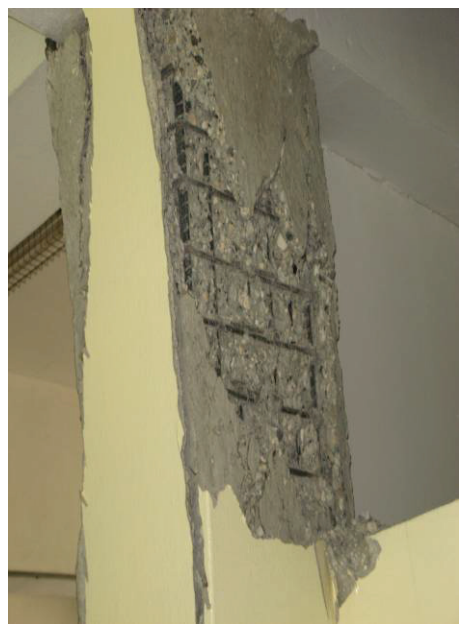
Figure 9: Confined core

Another tied column is shown in Figure 9. Despite the spalling, this column joint performed satisfactorily with the tie spacing likely adequate to confine the concrete core and retain the vertical load carrying capacity.

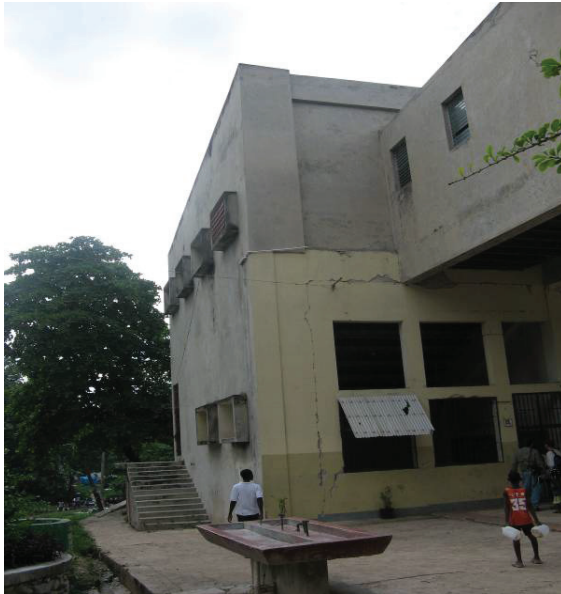
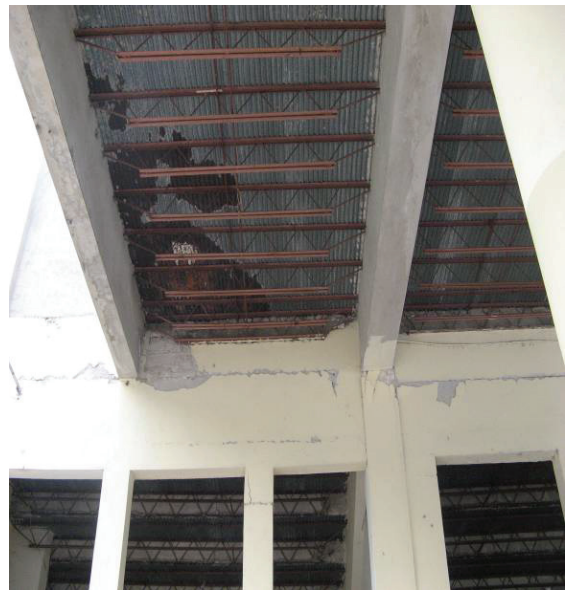
The large auditorium on this campus was damaged as shown in Figure 10. This damage is attributed to the large stiffness difference between the full height main structure and the structure covering the open plaza, imparting severe loading at the connection. The combined building appears to be highly unsymmetrical, introducing torsional effects at the extremities. Also the dynamic properties of the two parts of the structure are different and they may have responded primarily as individual elements rather than as a combined system, putting large demands on the junction region.

Figure 10(a): Failure of Wall in Auditorium

Figure 10(b): Close-up of failure zone

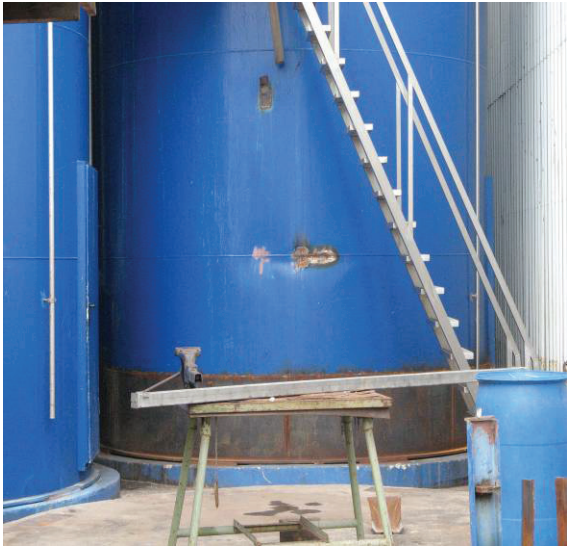
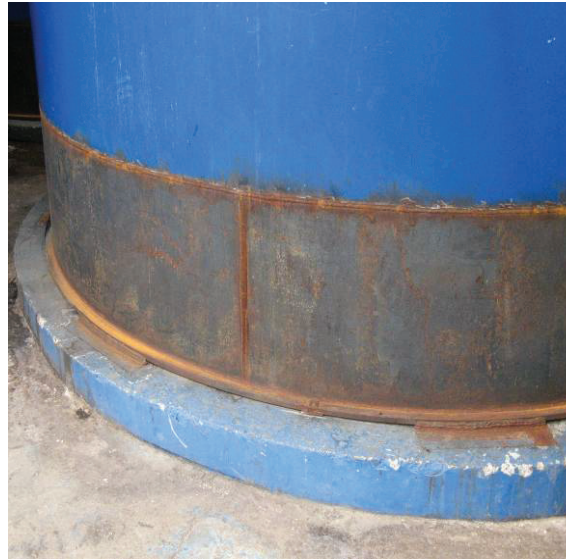
Several large steel fermentation tanks were damaged and repaired as shown in Figure 11. The repair at the base indicated that the tank may have suffered classical elephant's foot buckling but this was not confirmed. There were also failures at the base of some water tanks as shown in Figure 12 and an apparent overstressing of some of the steel moment frames as shown in Figure 13.

Figure 11(a): Repaired Steel Tank

Figure 11(b): Repair at Base

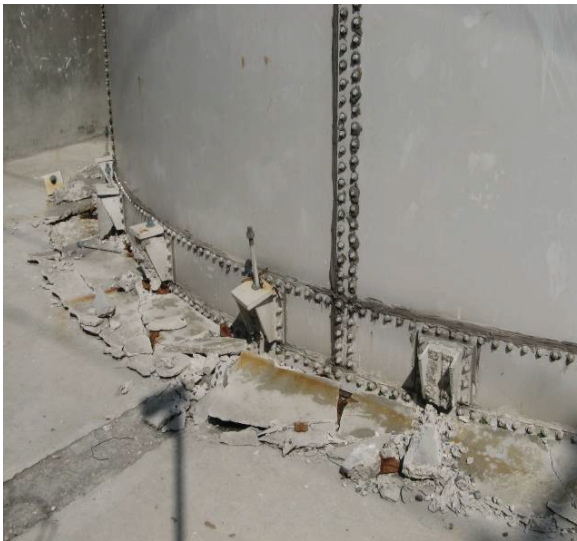
Figure 12: Base Attachment Failure

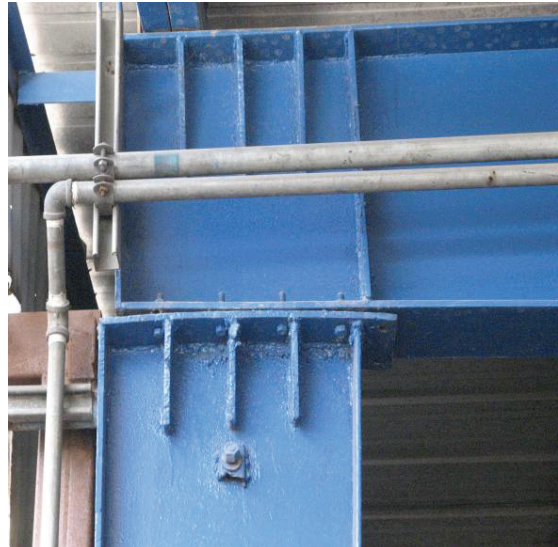
Figure 13: Deformed Joint in Steel Frame

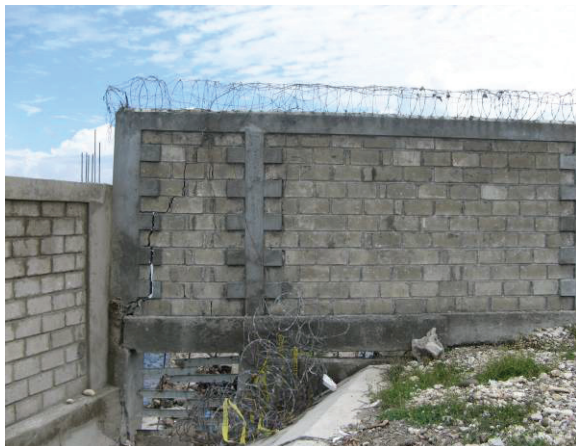
A failure near the end of the somewhat unusual masonry wall that encircles the plant is shown in Figure 14. This type of wall with concrete trees as vertical elements is common in Haiti. An overturned fuel storage tank is shown in Figure 15. Other similar tanks survived the earthquake.

Figure 14: Failure of Masonry Wall

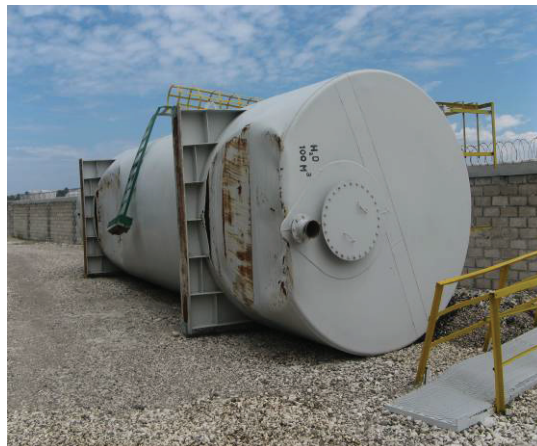
Figure 15: Overturned Fuel Storage Tank
