ADOBE CONSTRUCTION

Marcial Blondet and Gladys Villa Garcia M.
Catholic University of Peru, Peru

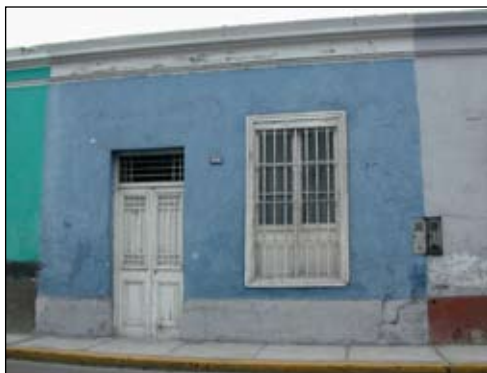
Figure 1: Typical adobe house (WHE Report 52, Peru)

Worldwide use of adobe is mainly in rural areas, where houses are typically one story, 3 m high, with wall thicknesses ranging from 0.25 m to 0.80 m. In mountainous regions with steep hillsides, such as the Andes, houses can be up to three stories high. In parts of the Middle East, one finds that the roof of one house is used as the floor of the house above. Urban adobe houses are found in most developing countries. However, they are not permitted by building codes in countries like Argentina, or in specific cities like San Salvador due to their poor seismic behavior.

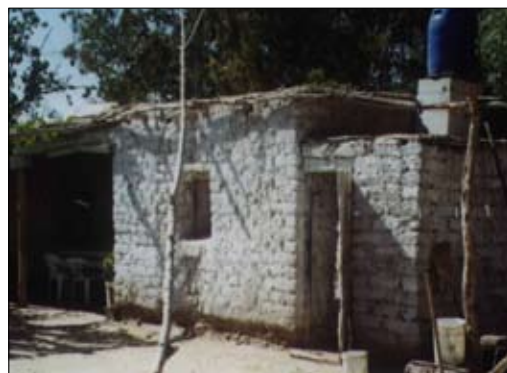
Figure 2: Typical adobe house (WHE Report 89, Argentina)

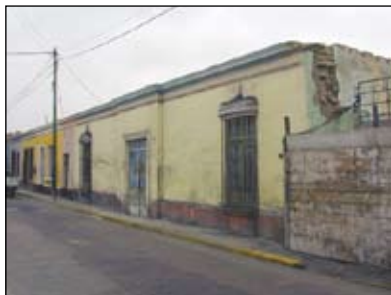
Figure 3: Typical adobe house in the coastal area

Architectural characteristics are similar in most countries: the rectangular plan, single door, and small lateral windows are predominant. Quality of construction in urban areas is generally superior to that in rural areas. The foundation, if present, is made of medium-to-large stones joined with mud or coarse mortar. Walls are made with adobe blocks joined with mud mortar. Sometimes straw or wheat husk (WHE Report 23, India) is added to the soil used to make the blocks and mortar. The size of adobe blocks varies from region to region. In traditional constructions, wall thickness depends on the weather conditions of the region. Thus, in coastal areas with a mild climate, walls are thinner than in the cold highlands or in the hottest deserts. The roof is made of wood joists (usually from locally available tree trunks) resting directly on the walls or supported inside indentations on top of the walls. Roof covering may be corrugated zinc sheets or clay tiles, depending on the economic situation of the owner and the cultural inclinations of the region. A traditional adobe house that exhibits good seismic behavior is the *bhonga* type,

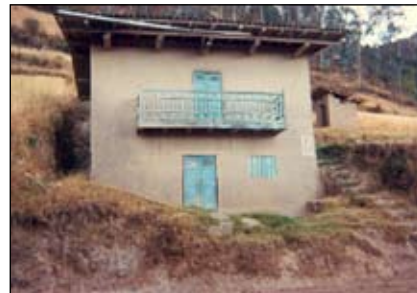
Figure 4: Typical adobe house in the highland area

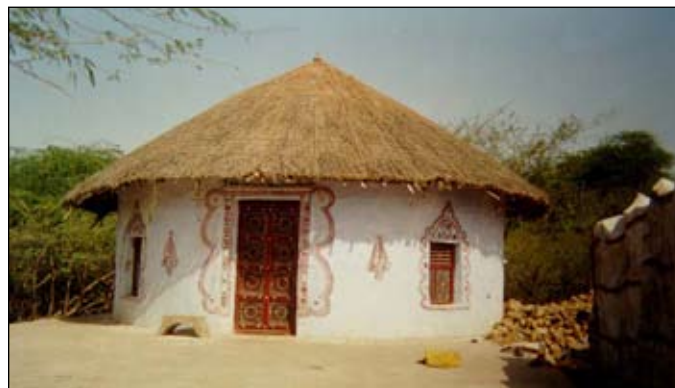
Figure 5: Typical adobe *bhonga* in India (WHE Report 72)

typical of the Gujarat state in India. It consists of a single cylindrically shaped room with conical roof supported by cylindrical walls. It also has reinforcing bonds at the lintel and collar level, made of bamboo or reinforced concrete.

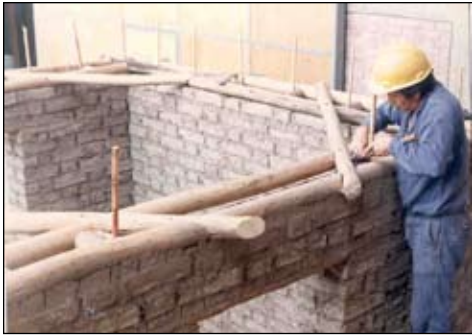
Figure 7: Crown beam made of eucalyptus trunks (Blondet et al. 2002, referenced in EERI adobe tutorial)

The most important factor for the improved seismic performance of adobe construction is to provide reinforcement for the walls. Earthquake shaking will cause adobe walls to crack at the corners and to break up in large blocks. The role of the reinforcement therefore is to keep these large pieces of adobe wall together. A ring beam (also known as a crown, collar, bond, or tie-beam, or seismic band) that ties the walls in a box-like structure is one of the most essential components of earthquake resistance for load-bearing masonry construction. The ring beam must be strong, continuous, and well tied to the walls, and it must receive and support the roof. The ring beam can be made of concrete or timber.

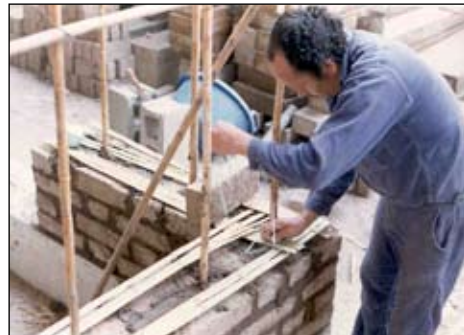
Figure 8: Tying adobe reinforcement (Blondet et al. 2002, referenced in EERI adobe tutorial)

Additional wall reinforcement should also be provided. This reinforcement can be made of any strong, ductile material, such as bamboo, cane, reeds, vines, rope, timber, chicken wire, barbed wire, or steel bars. Vertical reinforcement helps to tie the wall to the foundation and to the ring beam and restrains out-of-plane bending and in-plane shear. Horizontal reinforcement helps to transmit the out-of-plane forces in transverse walls to the supporting shear walls, as well as to restrain the shear stresses between adjoining walls and to minimize vertical crack propagation. The horizontal and vertical reinforcement should be tied together and to the other structural elements to provide a stable matrix that will maintain the integrity of the walls after they have broken into large pieces.

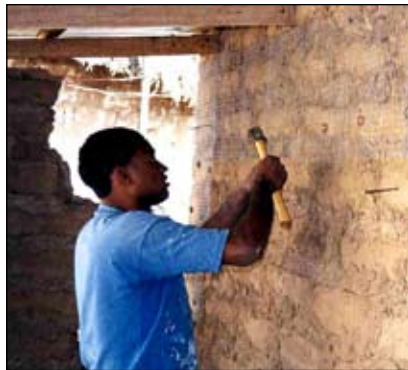
Figure 9: Nailing the wire mesh (Zegarra et al. 1997, referenced in the EERI adobe tutorial)

Dynamic tests conducted by researchers in Peru have demonstrated that a good solution for existing adobe houses is an external reinforcement consisting of wide strips of wire mesh (1 mm wires spaced at $\frac{3}{4}$ inches) nailed with metallic bottle caps against the adobe as shown in the figure below (Zegarra et al. 1997, referenced in WHE adobe tutorial). The mesh is placed in horizontal and vertical strips simulating beams and columns and is covered with cement and sand mortar. Several houses reinforced with this technique did not suffer any damage during the 2001 earthquake in the south of Peru, even though similar unreinforced houses in the vicinity collapsed or suffered significant damage.
