Cyclone-resistant houses for developing countries

Alan Mayo

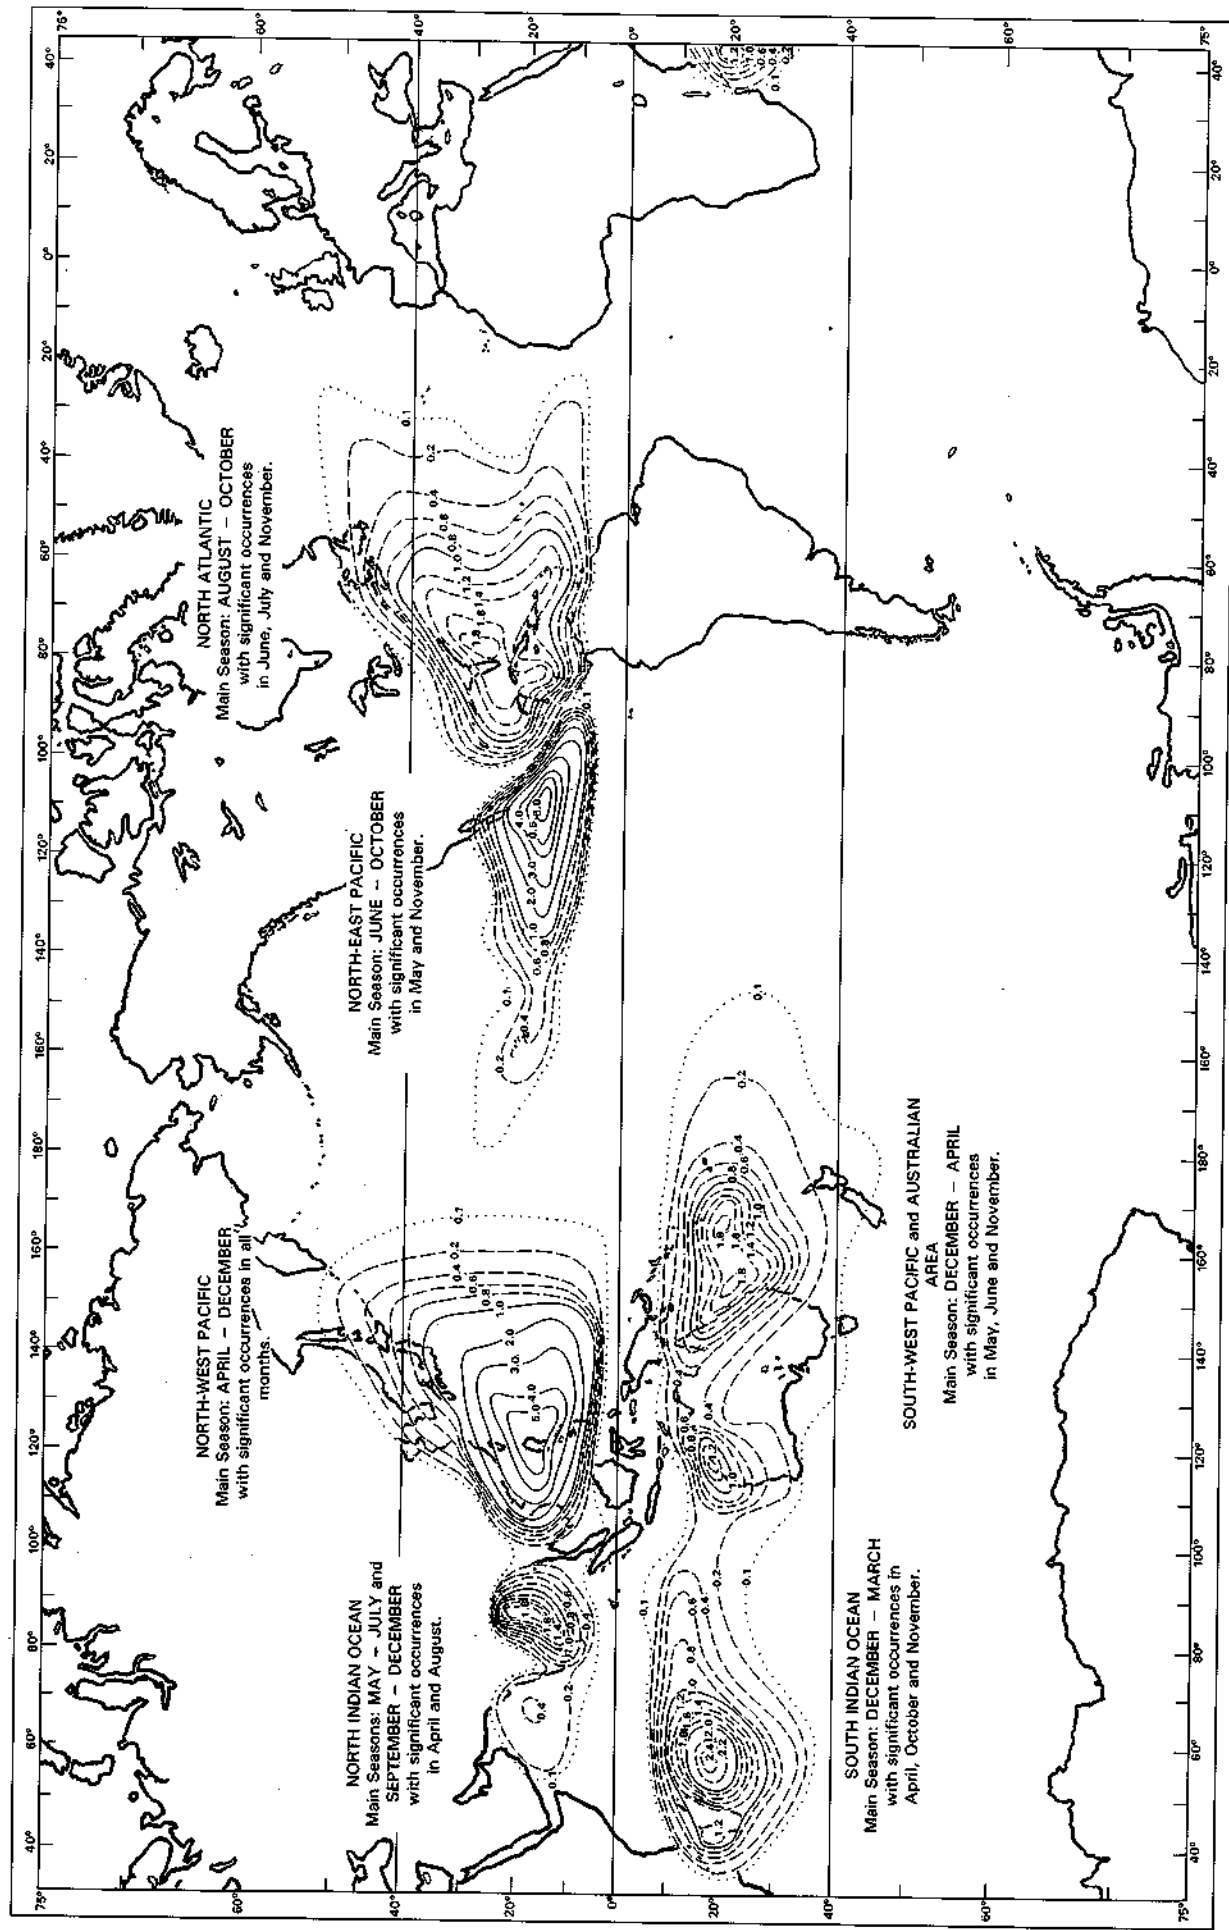
Figure 1 Areas of tropical cyclones showing the average number of occurrences per five-degree squares per year

Cyclones originate over tropical oceans and seas when air is still and the water warm. These conditions can exist for lengthy periods during late summer in six main areas of the world¹ (Figure 1). Many cyclones dissipate at sea but those which come ashore can cause serious damage to buildings (Figure 2) resulting in many people being made homeless as well as causing injury and loss of life.

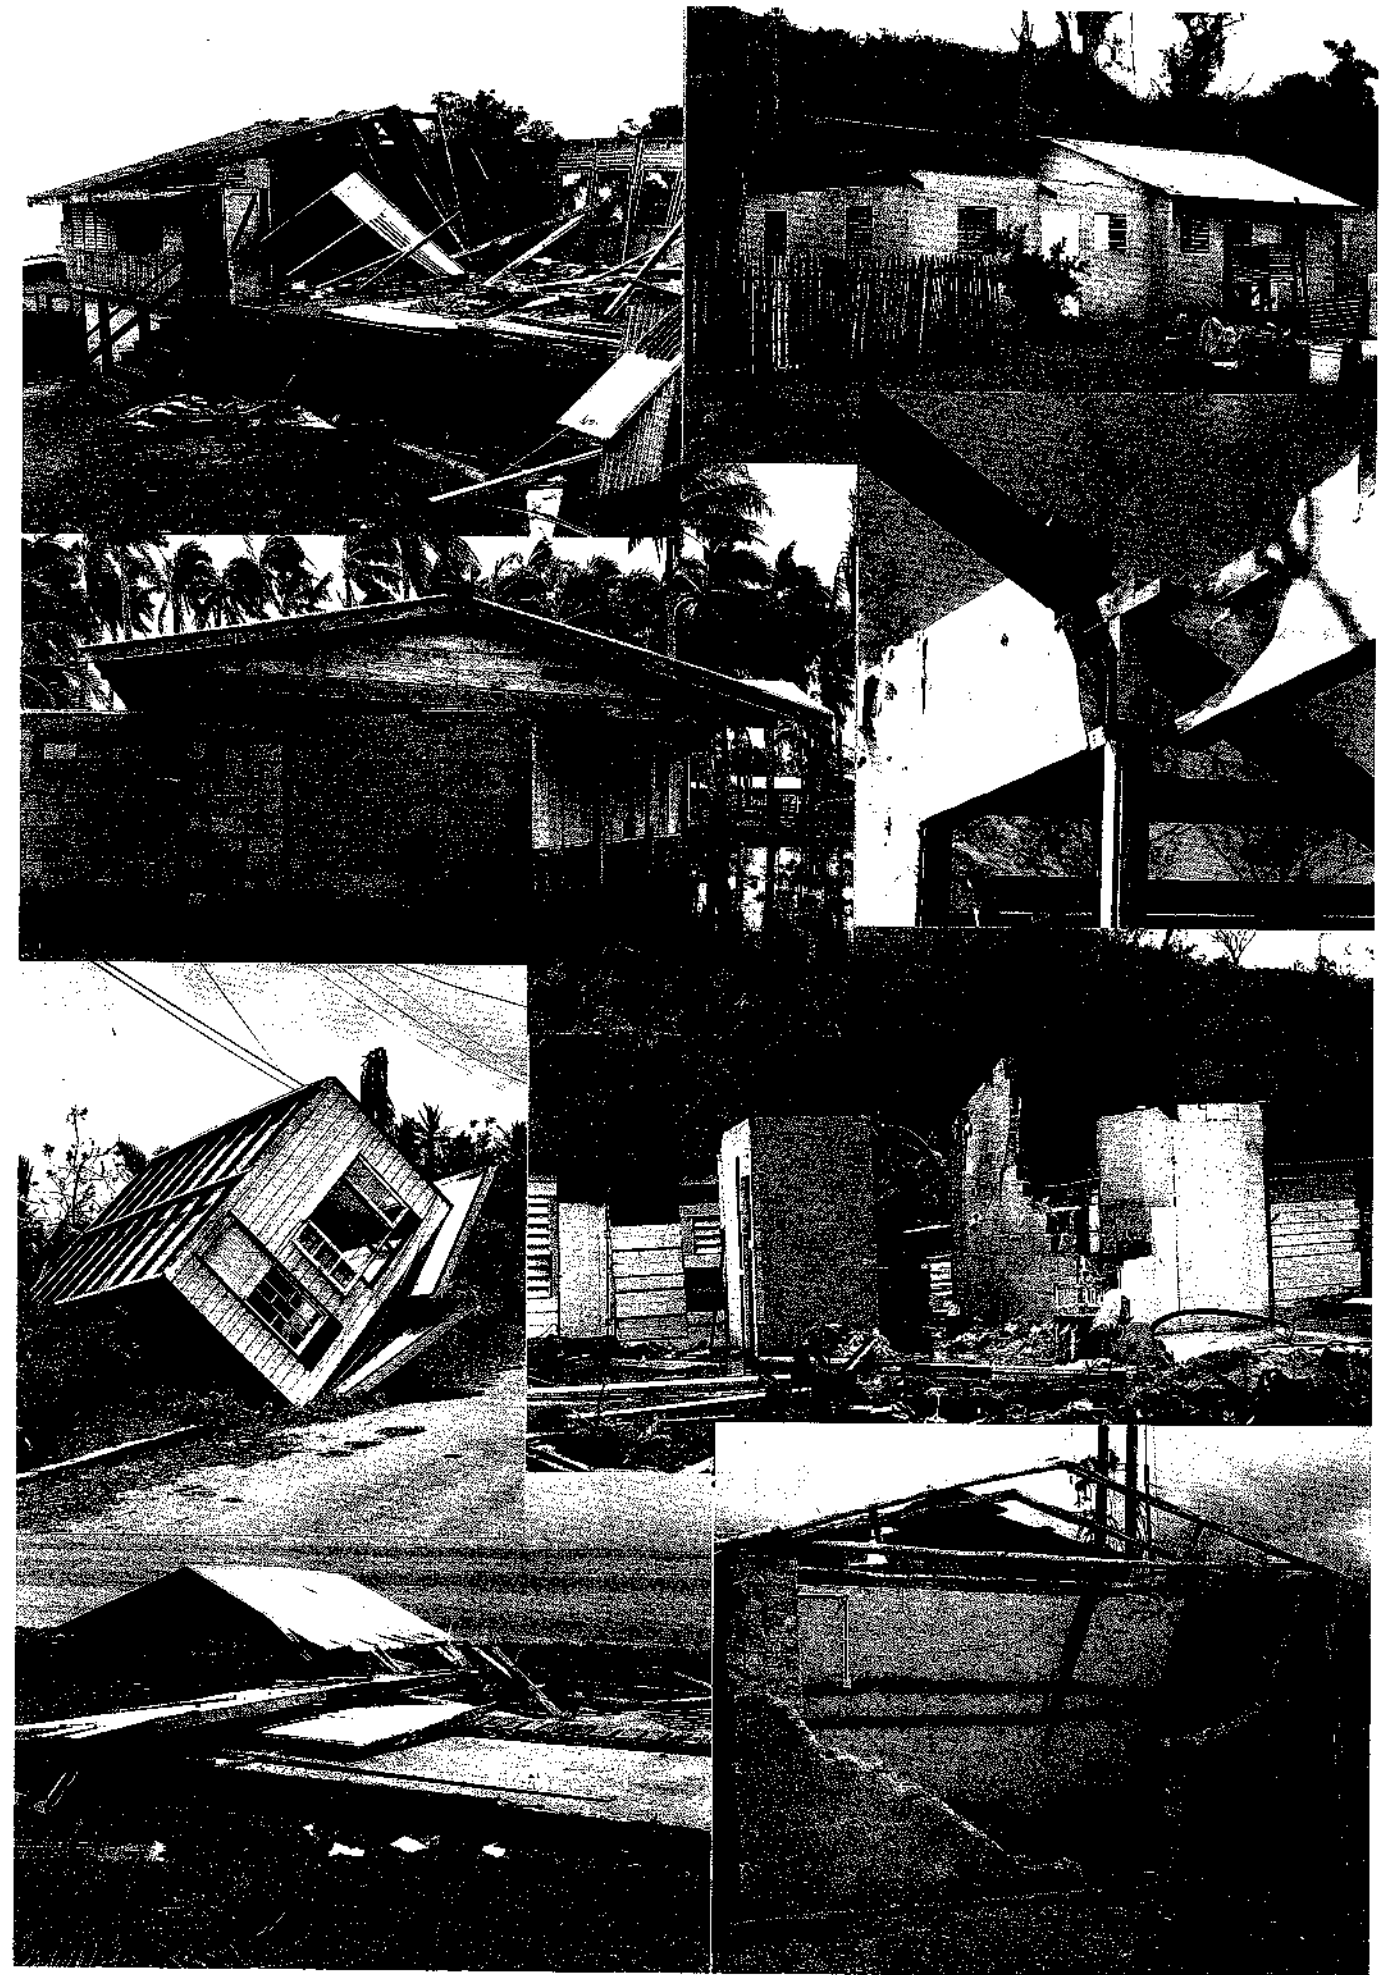
Figure 2 Examples of damage to buildings by cyclones

Serious damage occurs to some buildings owing to the failure of one or more of the main structural elements, but more frequently damage arises because of a lack of adequate fixings between the structural elements and between the buildings and its foundations. From a knowledge of wind speed, the shape and location of the building and the strength of the materials from which it is constructed, detailed calculations may be made to ensure that the building will safely resist the forces exerted on it during a cyclone²⁻⁵. However, by careful attention to a relatively small number of points, satisfactory low-cost housing may be constructed or strengthened using a variety of standard fixing details and components without the need for complex engineering calculations.

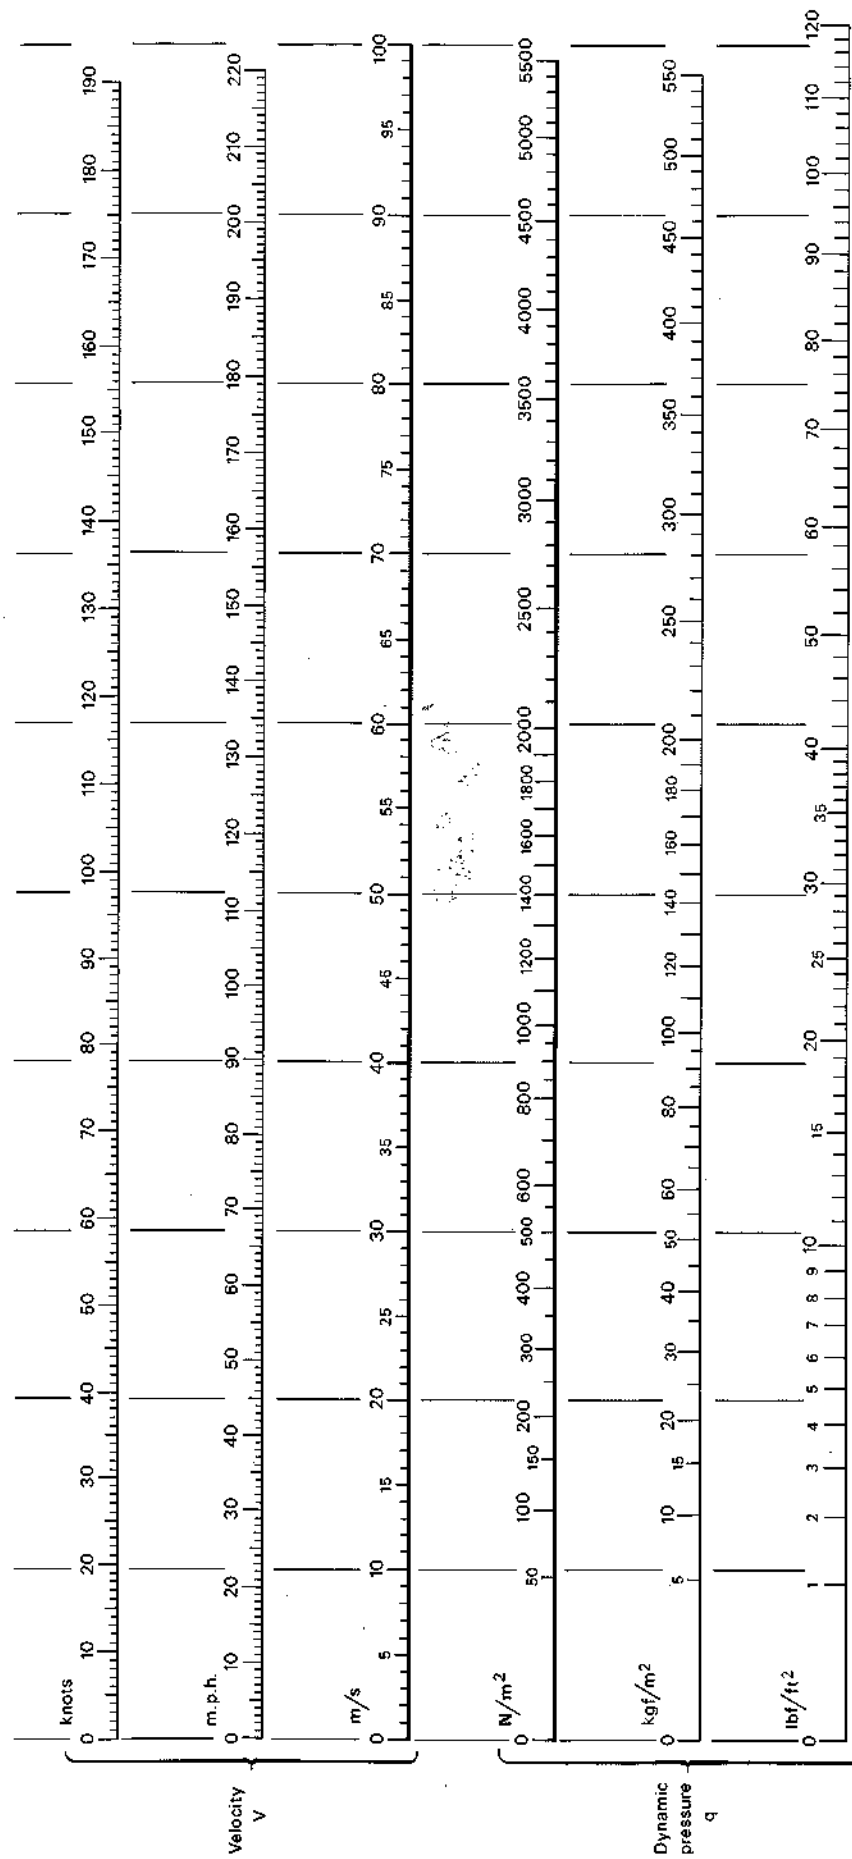
Table 1 Conversion chart for wind speed and dynamic pressure

1 m/s = 1.95 knots = 2.24 mph
 1 kgf = 9.81 Newtons (N) = 2.21 lbf

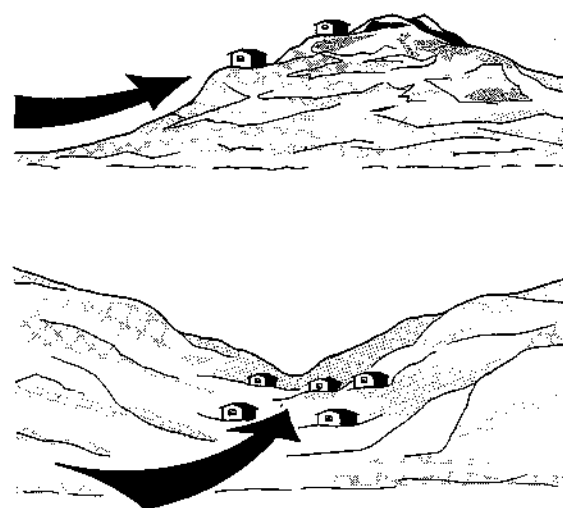
Figure 3 Hills and open-ended valleys increase wind speeds

Topography is an important factor influencing wind speeds, particularly near the tops of hills and along the bottoms of open-ended valleys where increases in wind speed of between 10 and 20% are common (Figure 3).

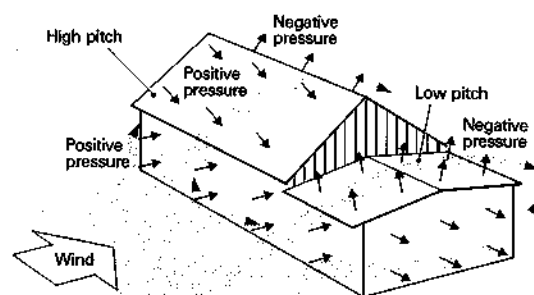
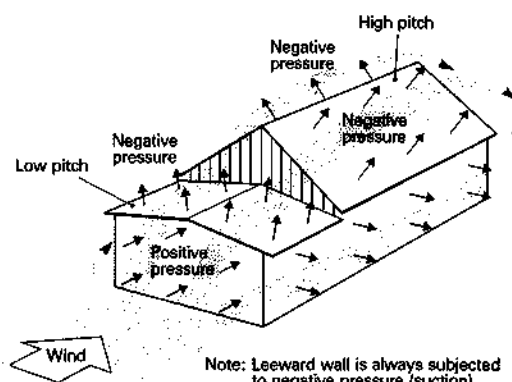
Note: Leeward wall is always subjected to negative pressure (suction)

Figure 4 Wind forces on walls and roofs of buildings are affected by direction of wind and shape of buildings

The forces exerted by the wind on the walls and roof of a building are governed not only by the wind speed, but also by the shape of the building and the direction of the wind relative to the building (Figure 4).

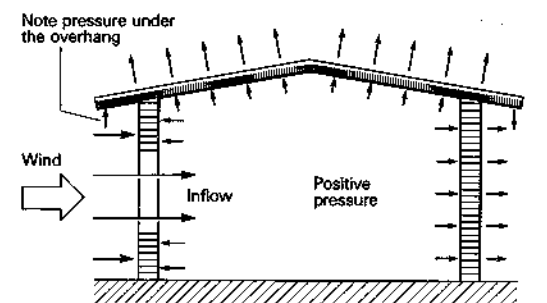
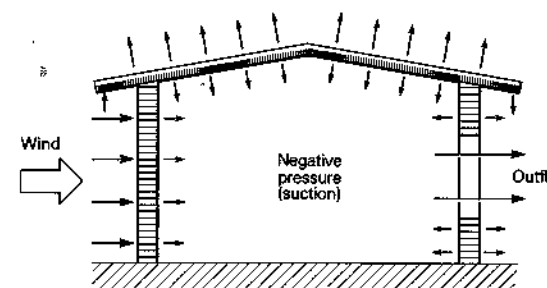
Figure 5 The effect of openings in windward and leeward faces

The total wind force on a wall or roof depends on the difference between the pressures on the inner and outer faces of the wall or roof. Open doors, windows and ventilators on the windward side of a building cause the air pressure to increase inside the building. This has the effect of increasing the total force on those elements of the building which experience external negative pressures, and reducing the total force on those elements subjected to external positive pressures (Figure 5).

Conversely, openings in walls in the lee or parallel to the wind direction cause a reduction in air pressure inside the building. This increases the total force on the windward wall and counteracts the external negative pressures on the remaining walls and the roof.

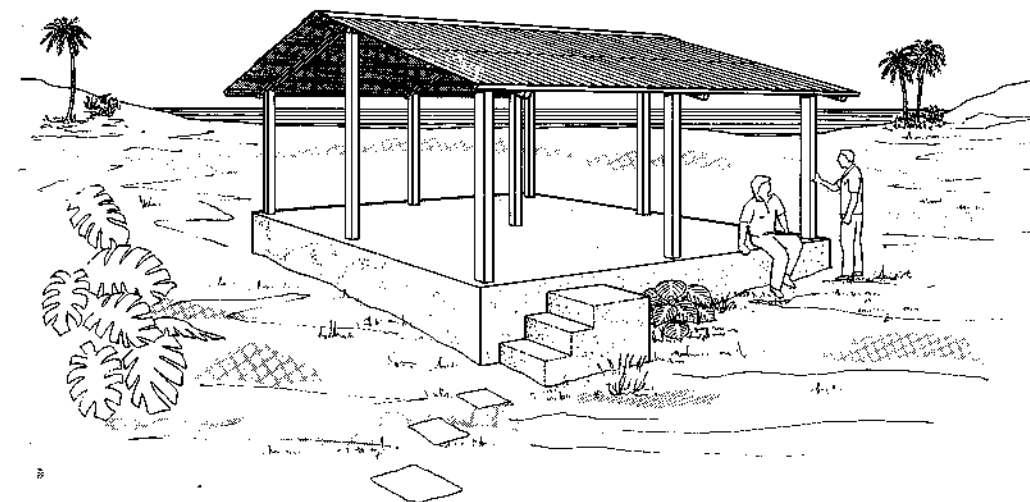
Figure 6 Building Research Establishment/Housing & Land Development Corporation St Vincent low-income house (type 1) — 45 square metres

House 1 (Figure 6) is 7.3 m × 6.1 m in plan with a solid concrete floor. The hardwood columns, beams, rafters and purlins are interconnected with rigid brackets and the roof clad with 'Onduline', a corrugated bitumen-fibre sheeting.

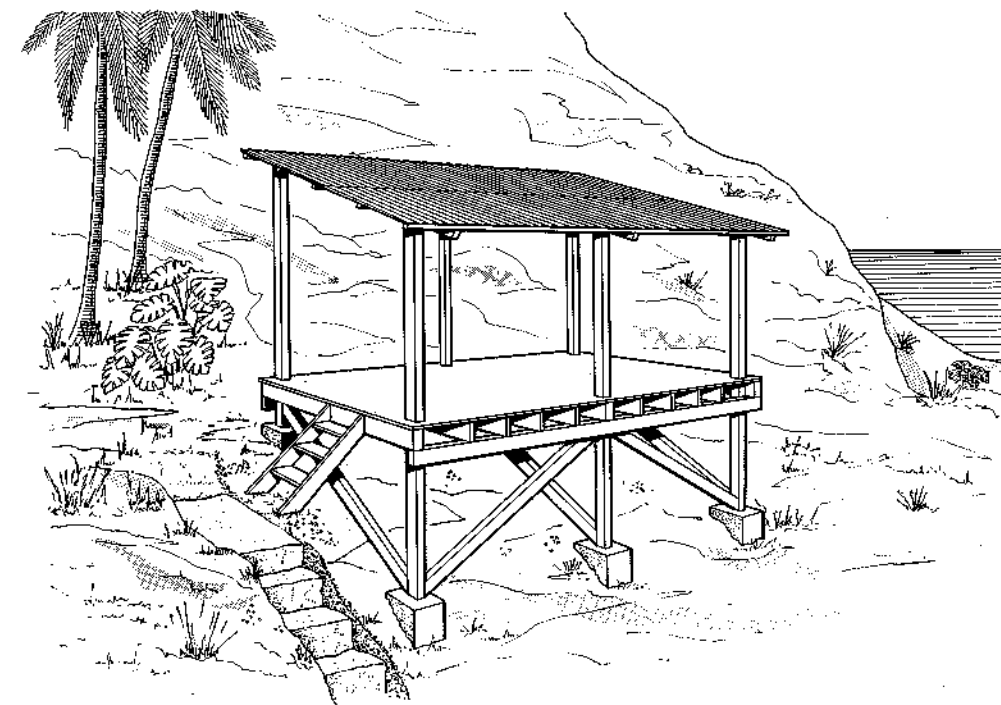
Figure 7 BRE-HLDC St Vincent low-income house (type 2) — 19 square metres

House 2 (Figure 7) is 6.1 m × 3.0 m in plan with a hardwood substructure and floor. Again, the hardwood columns, beams, rafters and purlins are all inter-connected with rigid brackets and the roof clad with 'Onduline' sheeting.

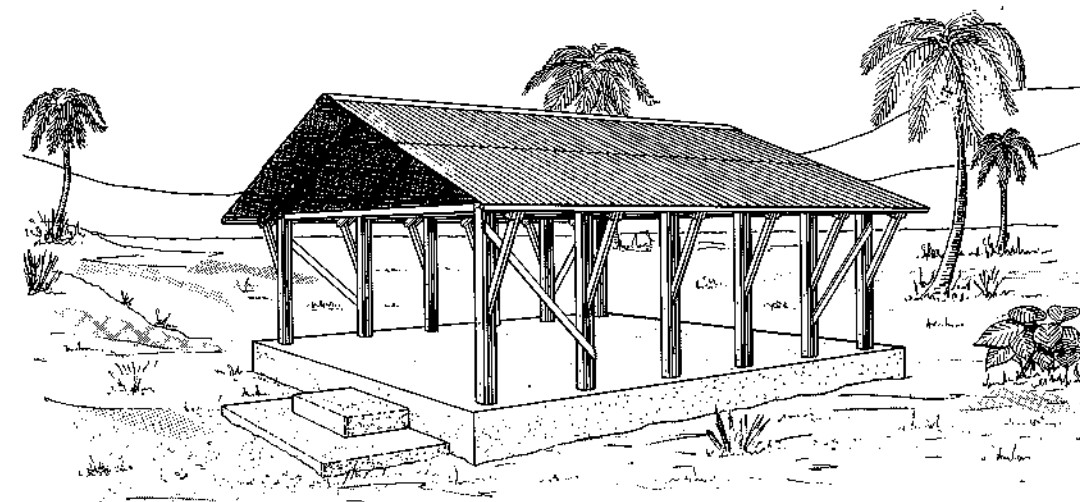
Figure 8 BRE-HLDC St Vincent low-income house/community building — 51 square metres

House 3 (Figure 8) is 7.3 m × 6.1 m in plan with a solid concrete floor. It has reinforced hollow-concrete block columns with a hardwood ring-beam, trusses and purlins, all rigidly interconnected and supporting 'Onduline' roof sheeting.

Subsequently, a fourth design was developed and a trial house constructed (Figures 8 and 9). The main features of this design are the structural strength, ie resistance to earthquakes and hurricanes; the low cost and ease of construction — permitting considerable prefabrication with the frames assembled in a jig; the use of single-size timber (50 x 100 mm) and single-size bolted joints throughout; a wide clear span up to 6.1 m, and unlimited length providing a building capable of many uses from single-family housing to community buildings such as schools and medical centres.

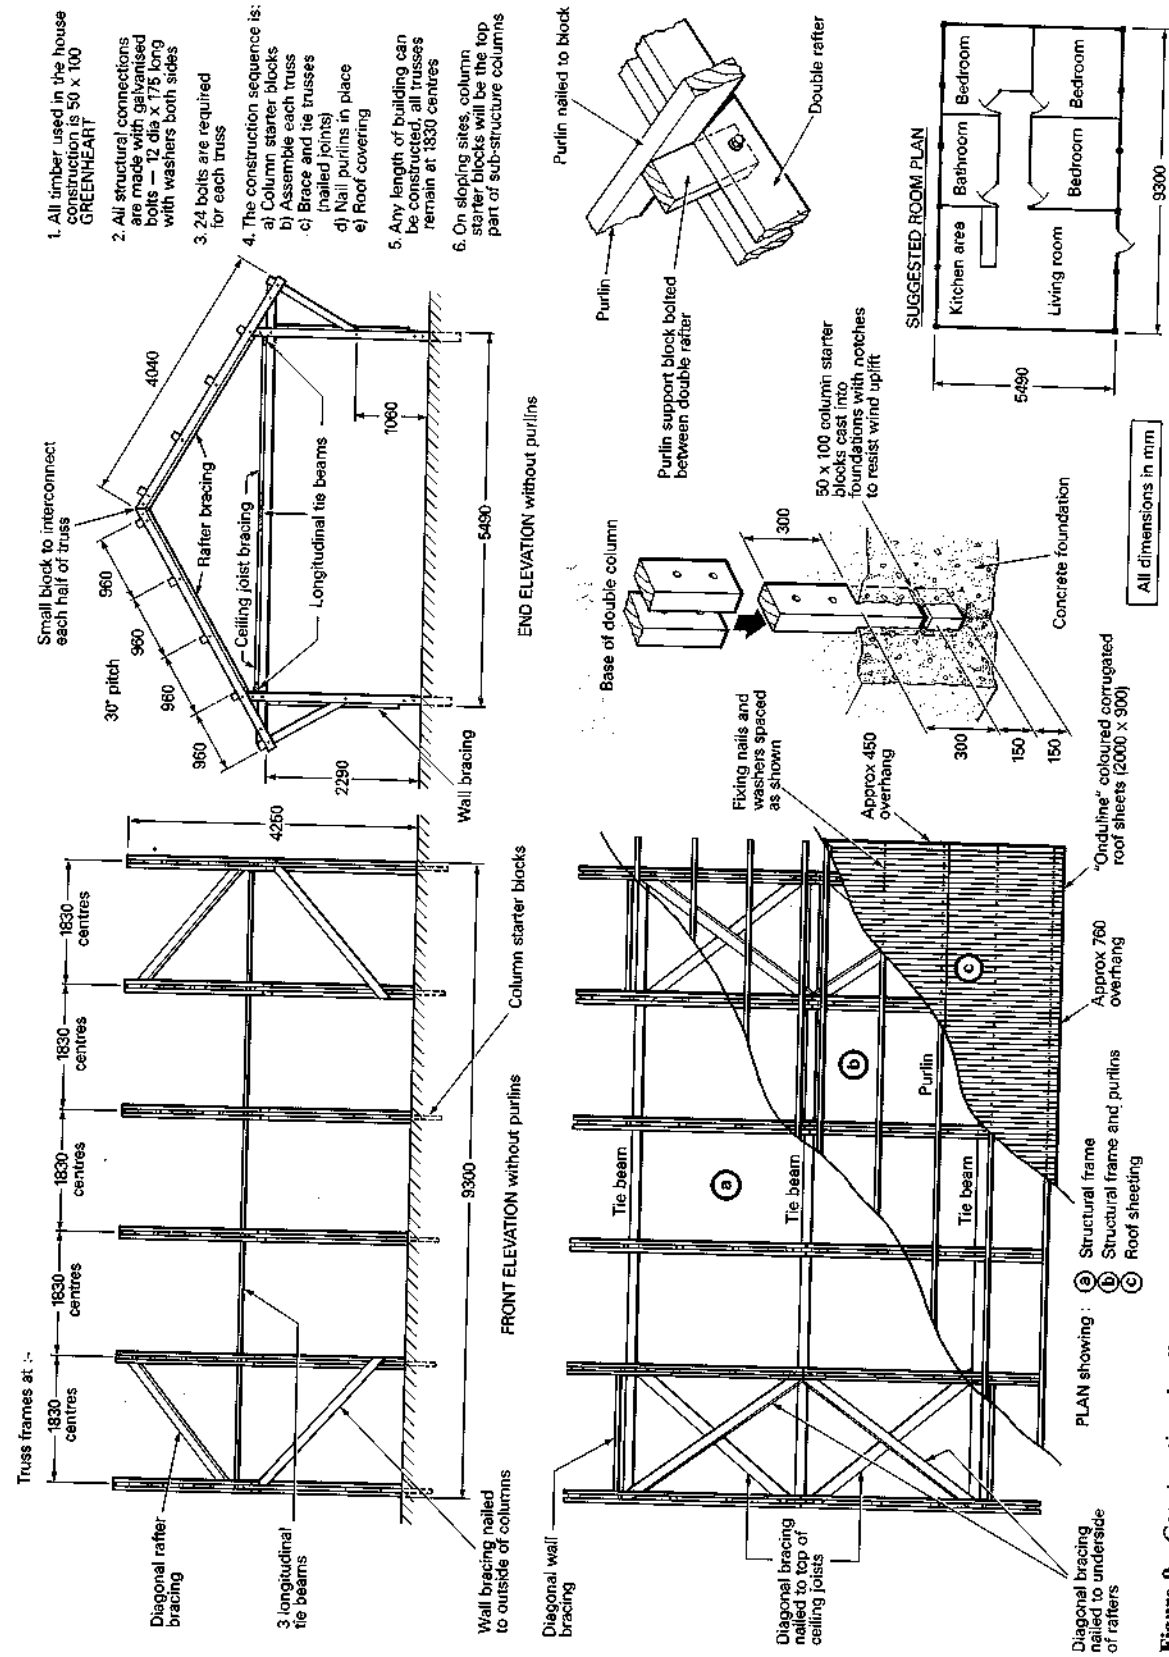
Figure 9 Construction details of St Vincent low-income house/community building

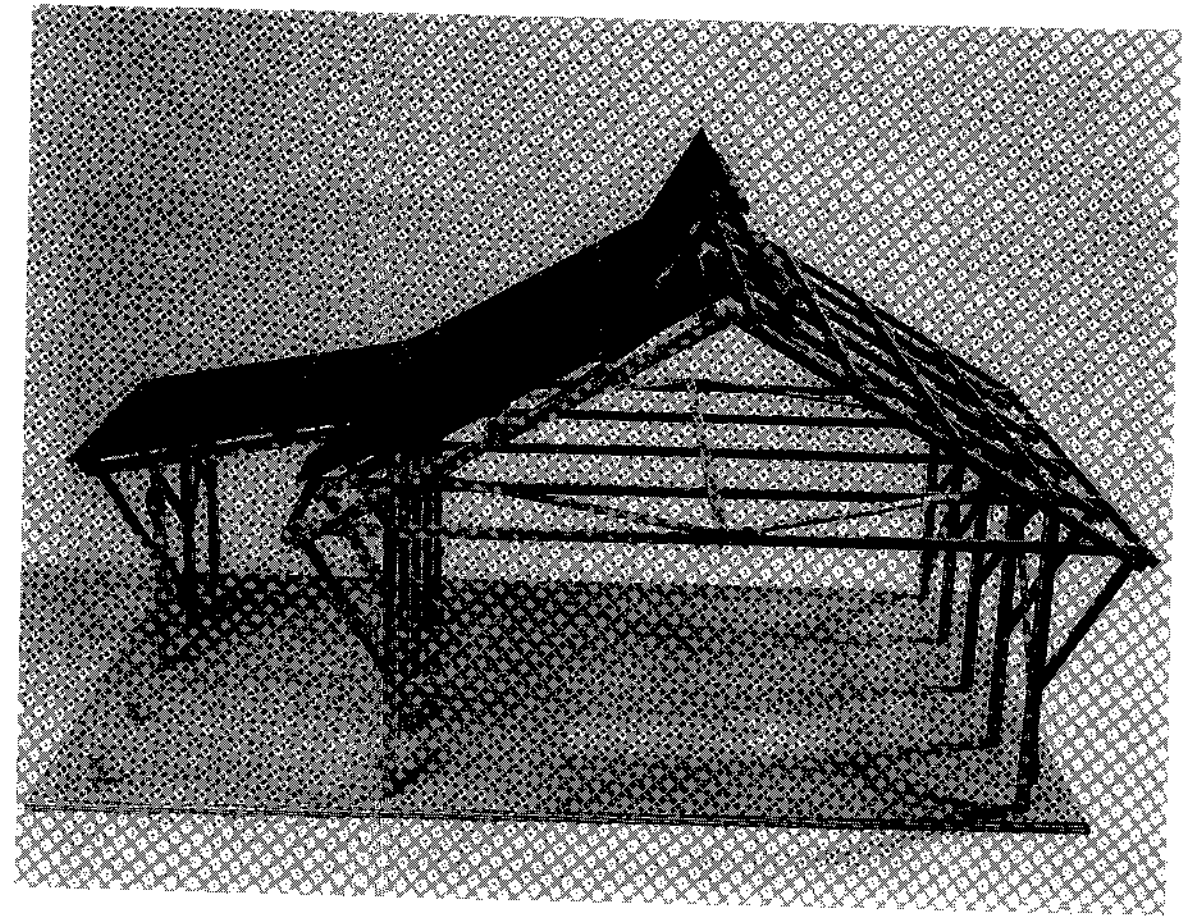
Figure 10 Model of Fiji house with high-aspect roof and side extension

SOUTH PACIFIC. BRE has examined the problems associated with cyclone damage to buildings in Fiji, Tonga, Vanuatu and the Solomon Islands. Where appropriate, detailed technical advice has been given concerning risk assessment and cyclone-resistant construction methods. An example of low-cost cyclone-resistant building design suitable for single family housing was demonstrated to the Fiji Housing Authority using a scale model. This was based on experience gained in the Caribbean, the structure being a development of the St Vincent low-income house/community building (Figure 8) modified to meet specific housing requirements in Fiji (Figure 10).

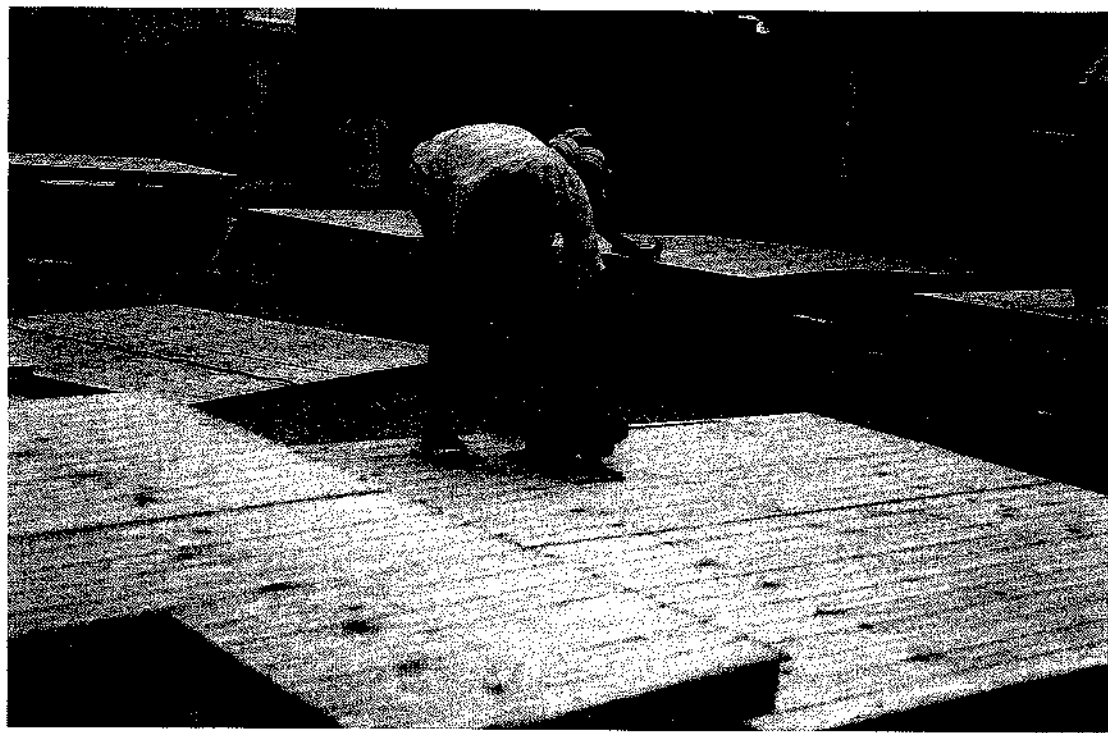
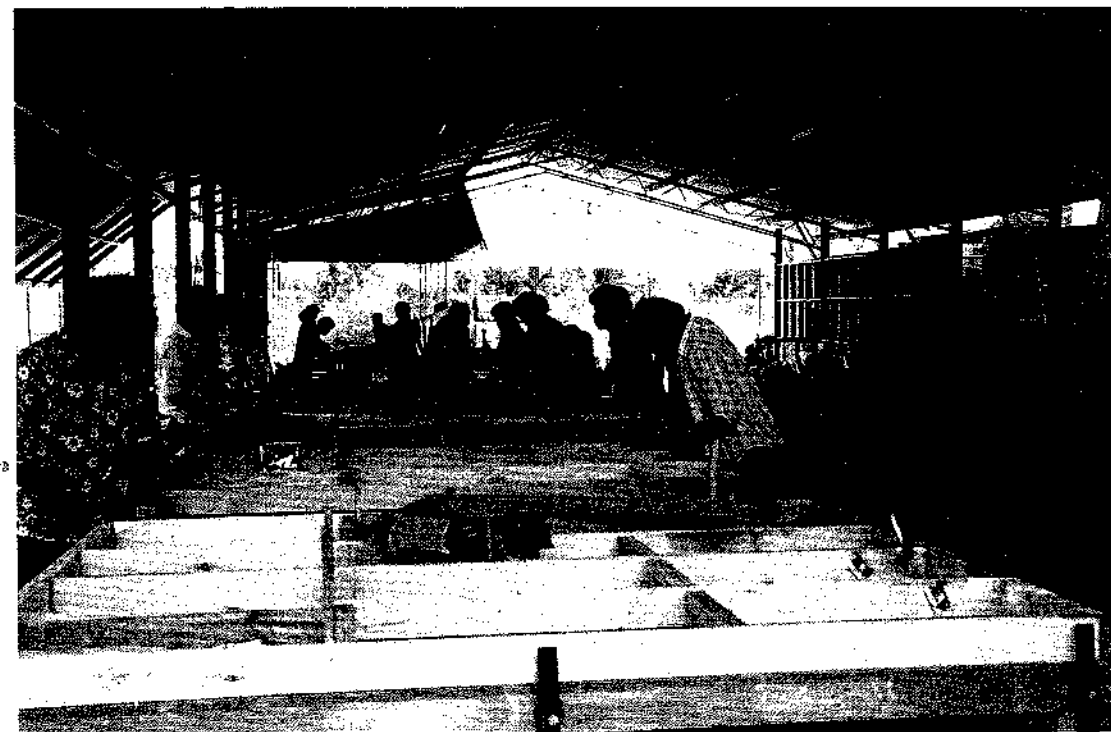
Figure 11 Factory prefabrication of Tongan housing

Figure 12 Factory prefabrication of Tongan housing

Following the devastation caused on islands of the Kingdom of Tonga by cyclone 'Isaac' in March 1982, a major house-building programme was undertaken using timber frame construction methods with the panels prefabricated under factory conditions (Figures 11 and 12).

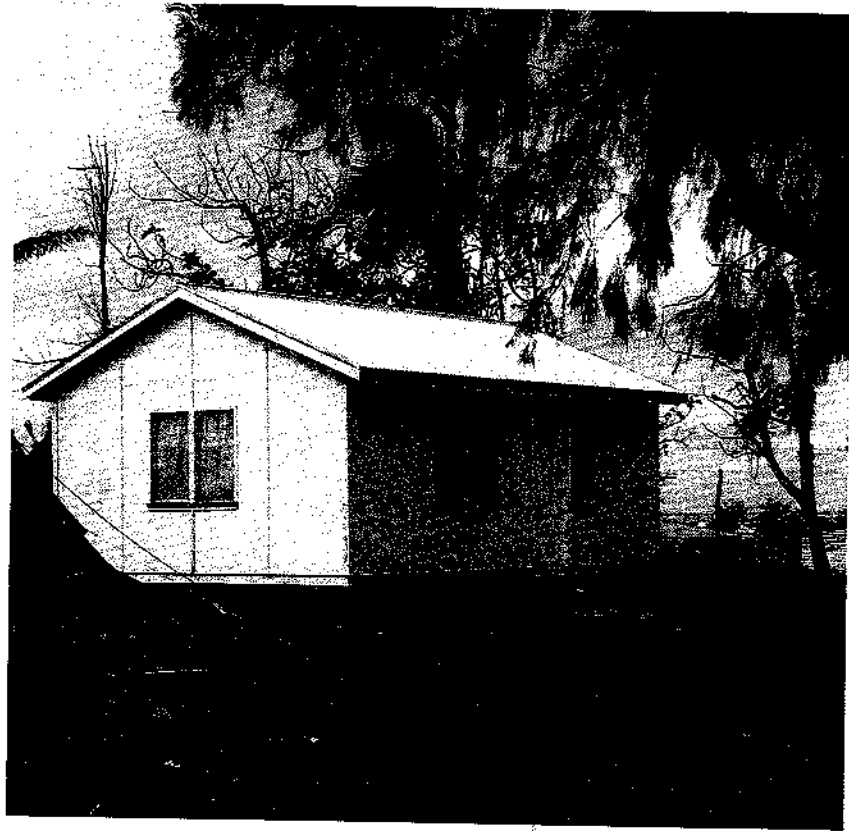
Figure 14 Basic Tongan house with suspended timber floor on timber piles cast in concrete footings

The design was developed jointly by the Tongan Ministry of Works and BRE with specialised advice provided by the Cyclone Testing Station in Townsville, Queensland¹³. The walls were formed with modular panels 2.4 m long, fabricated with 50 × 100 mm studs at 600 mm centres and sheathed with plywood or fibre cement boards. The roofs were constructed with timber trusses jointed with plywood gussets or hammer-in type metal tooth plates, and clad with corrugated galvanised steel sheets. Proprietary steel straps (framing anchors) were used to fix the roof purlins to the trusses, and the trusses to the wall panels (Figure 13). Examples of the finished houses are shown in Figures 14 and 15.

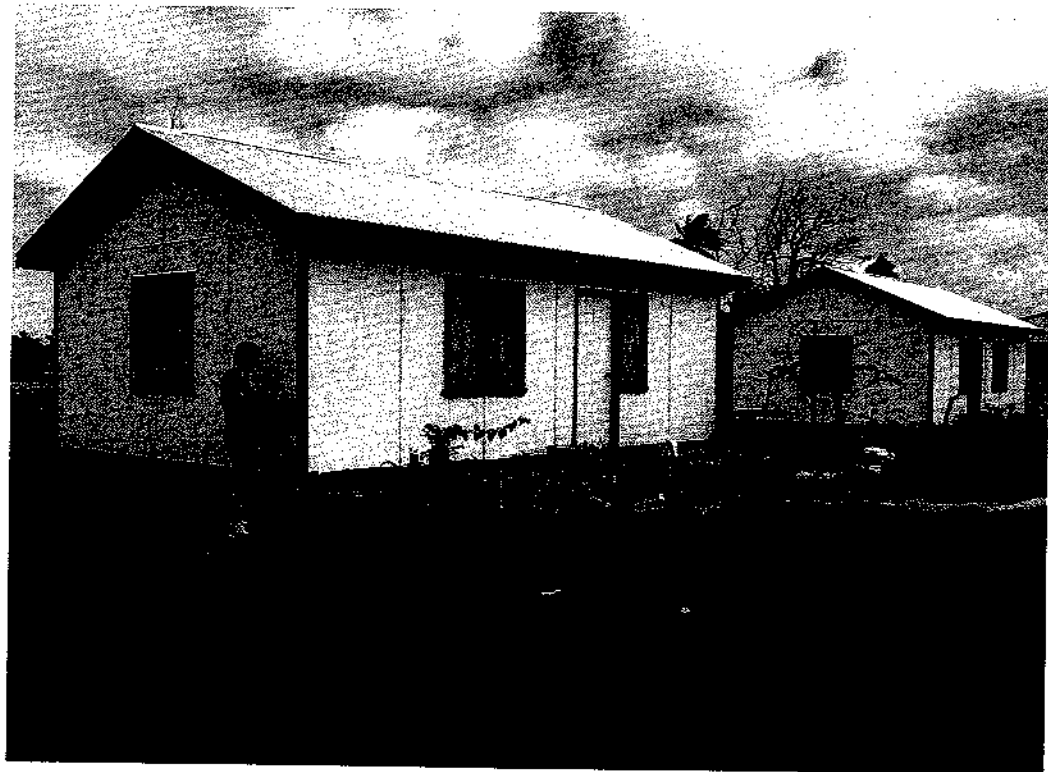
Figure 15 Basic Tongan house with solid concrete raft ground floor

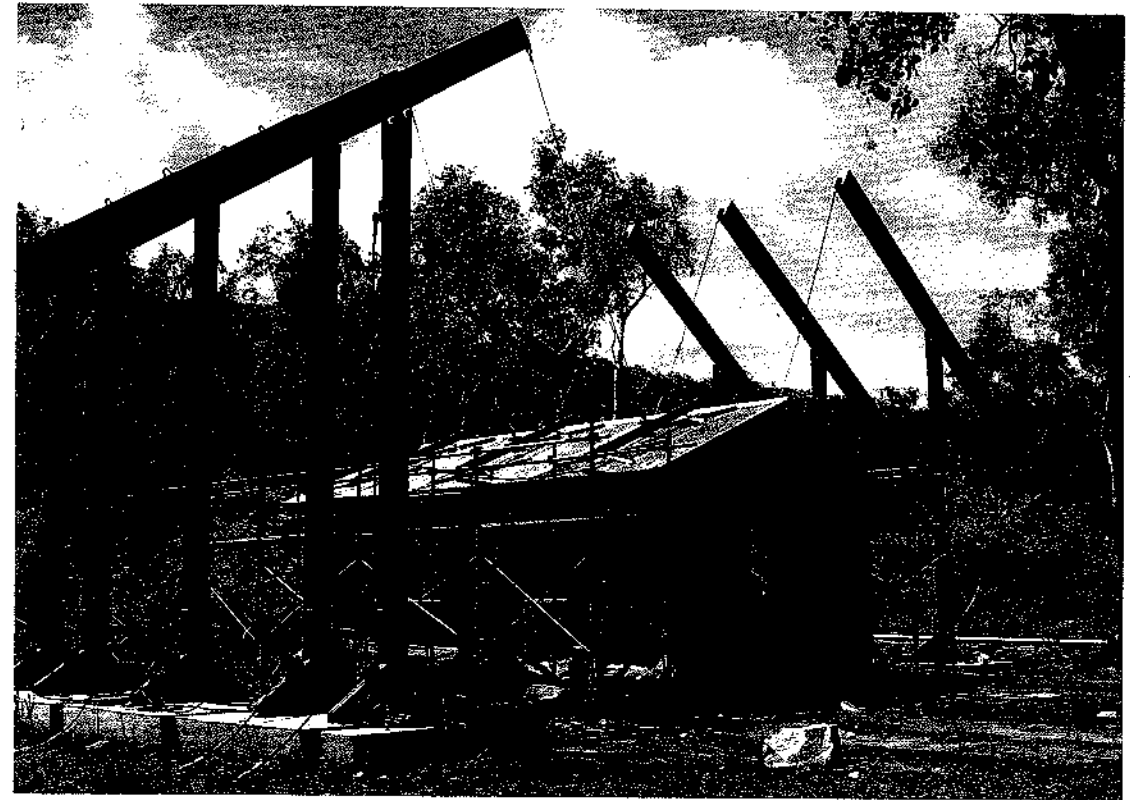
Figure 16 Cyclic loading tests on basic Tongan house

At an early stage of the house building programme, a complete kit of house components was shipped from Tonga to the Cyclone Testing Station in Queensland where it was erected using the same construction techniques as used in Tonga. A series of cyclic loading tests¹⁴ was made on this test house (Figure 16).

These tests showed that the size and location of the steel straps tying the roof trusses to the wall panels were critical details so they were replaced by a timber batten placed over the ends of the trusses and bolted through to the top plates of the wall panels. Following this modification, further tests showed that the basic house design could safely resist a simulated four-hour cyclone with wind gusts up to a design velocity of 62 m/s.

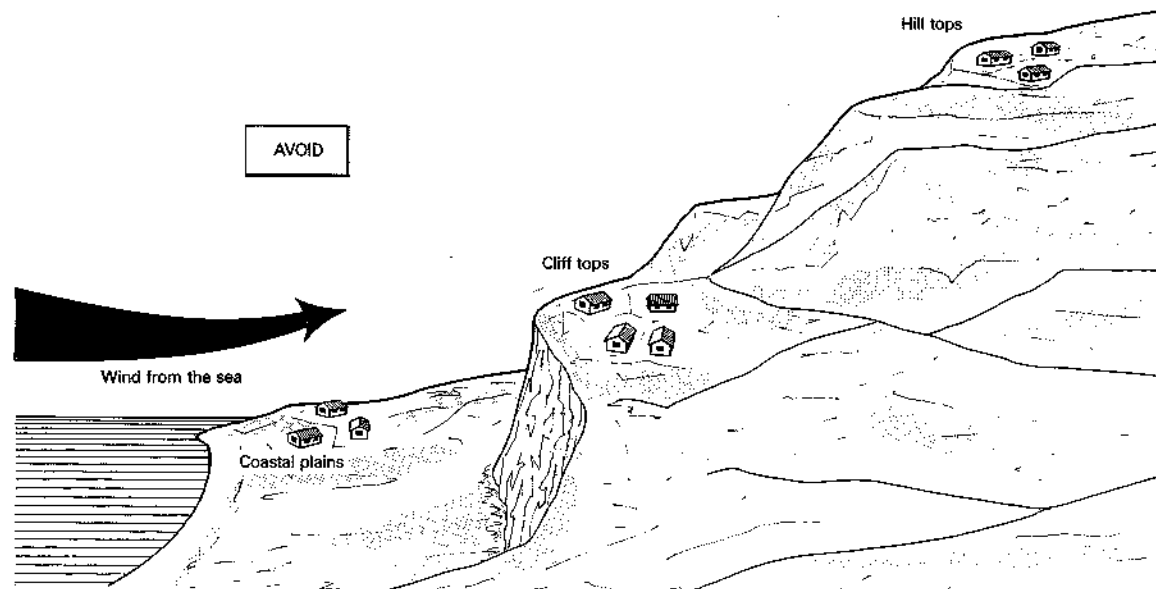
Location. Avoid building in exposed areas and on sites that are close to abrupt changes in ground level.

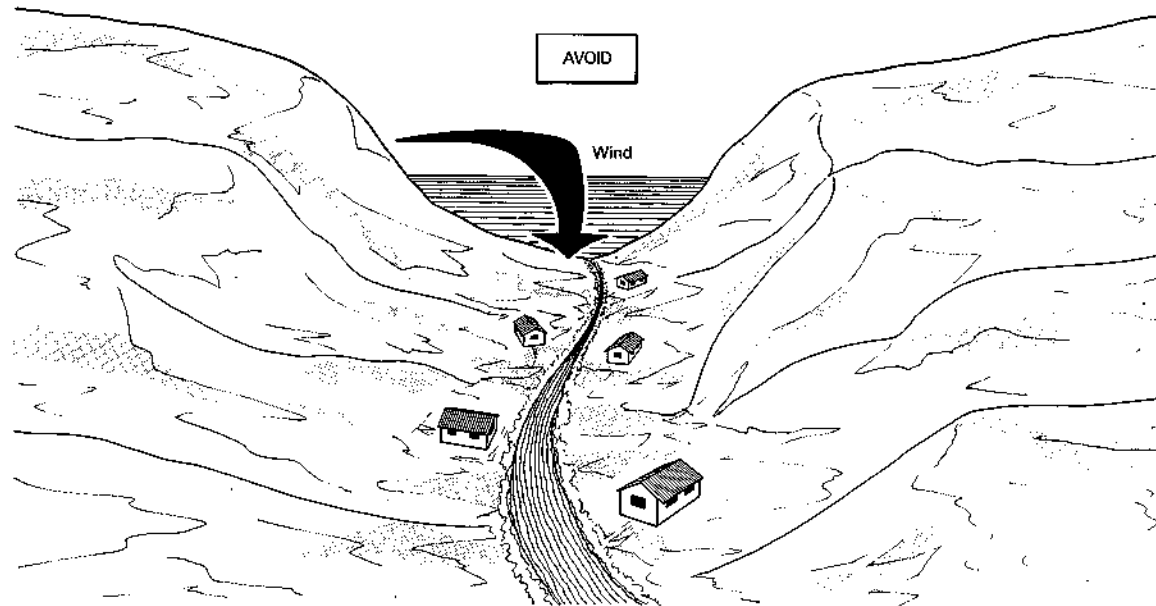
Avoid building in steep-sided valleys which open onto a beach and sea.

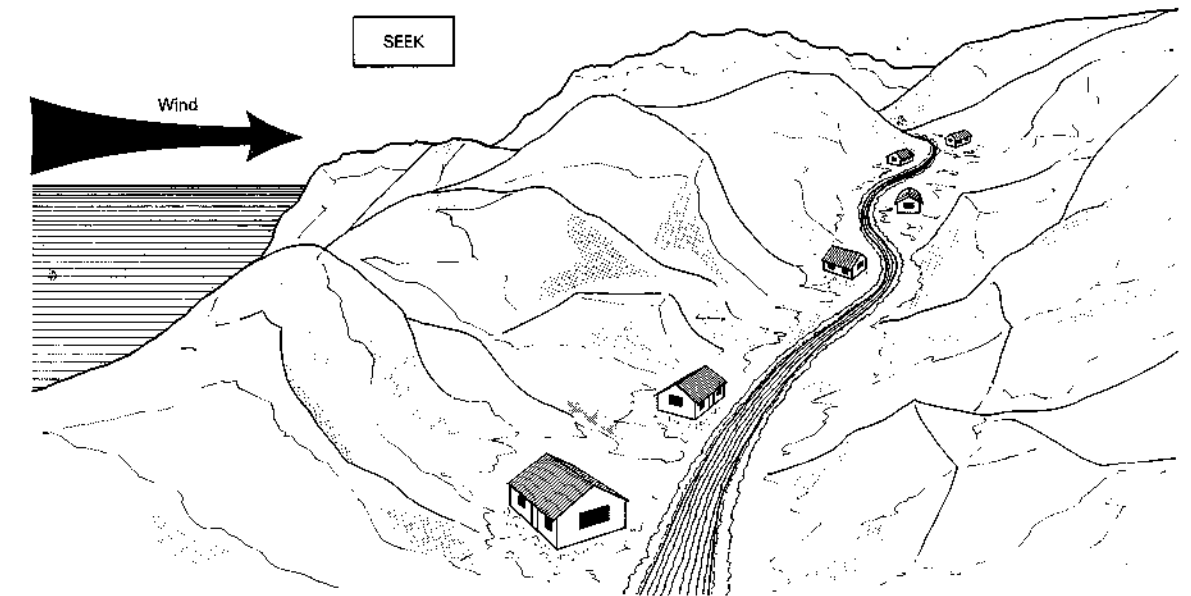
Take advantage of natural shelter provided by enclosed valleys not open to the sea, even though for some wind directions shelter will be much reduced.

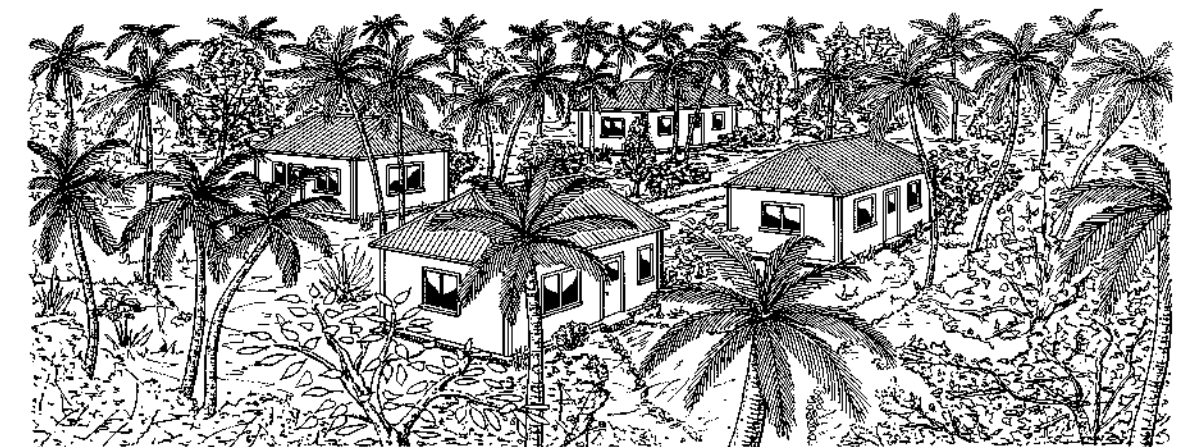
Site buildings in groups' making use of natural vegetation to provide limited but significant wind breaks.

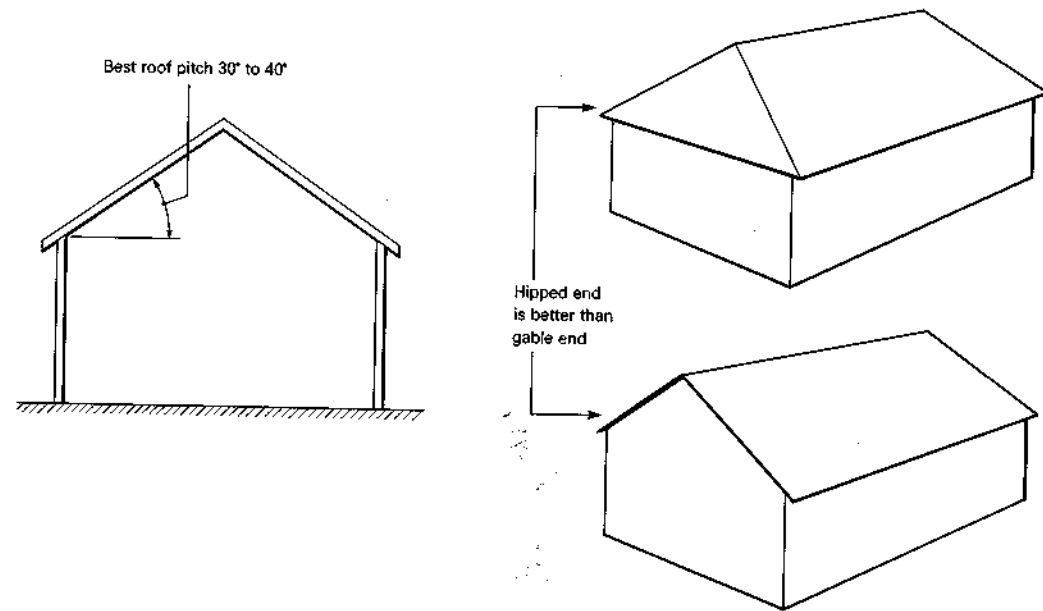
Shape. To reduce the uplift forces, build roofs with pitches between 30° and 40° and if possible provide high-level ventilation at the ridge. When possible, use hipped ends rather than gable ends.

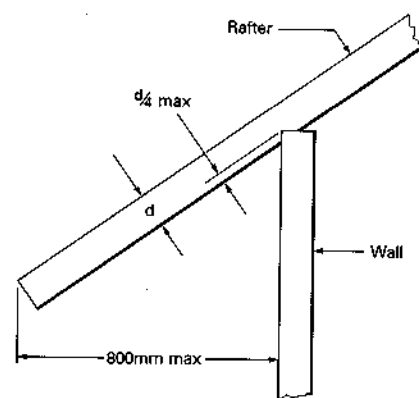
Restrict unsupported eaves overhangs to not more than 800 mm from the wall and do not notch rafters over walls by more than one-quarter of the rafter depth.

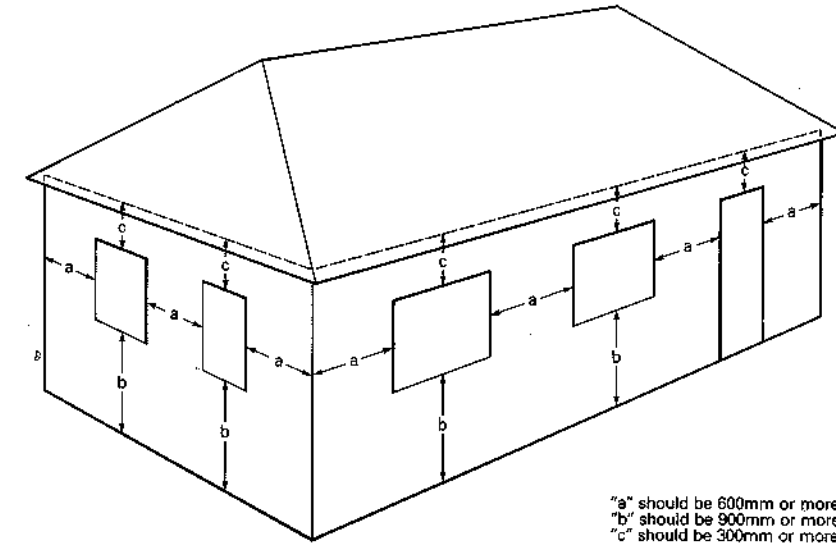
Openings. To minimise the reduction in strength caused by openings in walls for doors and windows, openings should not be positioned close to corners, the eaves or the floor.

"a" should be 600mm or more
 "b" should be 900mm or more
 "c" should be 300mm or more

For each wall, the sum of the lengths of wall between openings (ie dimension 'a' should be not less than half the overall length of the wall.
