Cyclone-resistant houses for developing countries

Alan Mayo

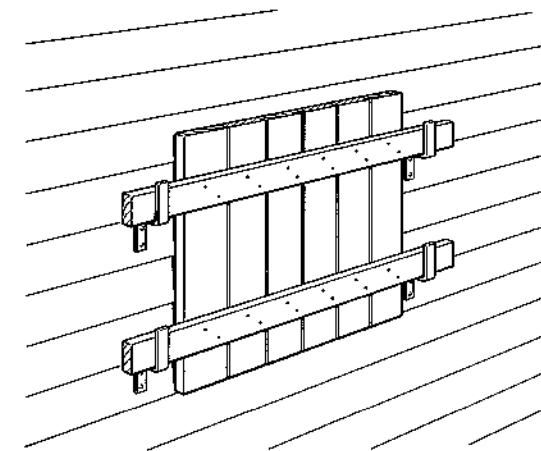
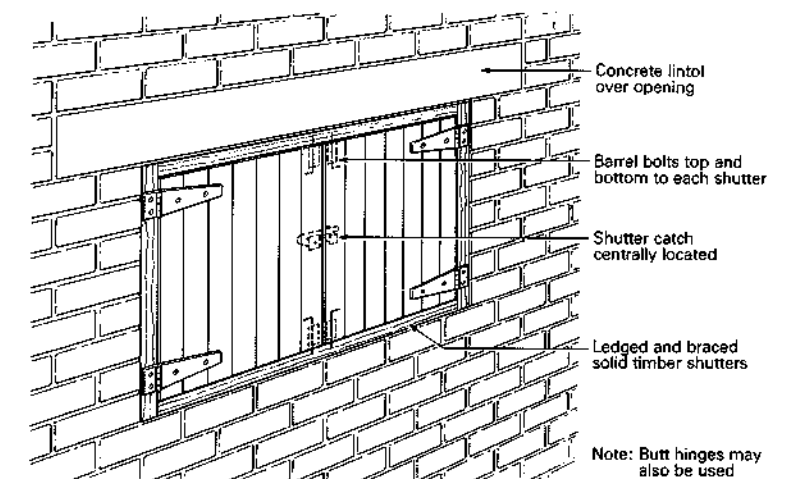
Keep the size of windows as small as possible in the most exposed walls, eg those facing seaward, and position doors in other walls.

During cyclones, secure all windows and cover with removable or hinged shutters to avoid damage and prevent the build-up of high internal pressures.

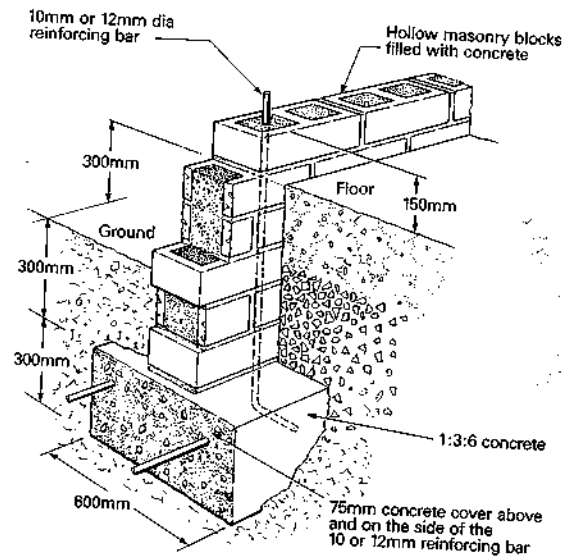
Foundations. For masonry walls use concrete strip footings and hollow masonry blocks filled with concrete to 150 mm above floor level. The concrete should be 1 part cement to 3 parts fine aggregate (sand) to 6 parts coarse aggregate.

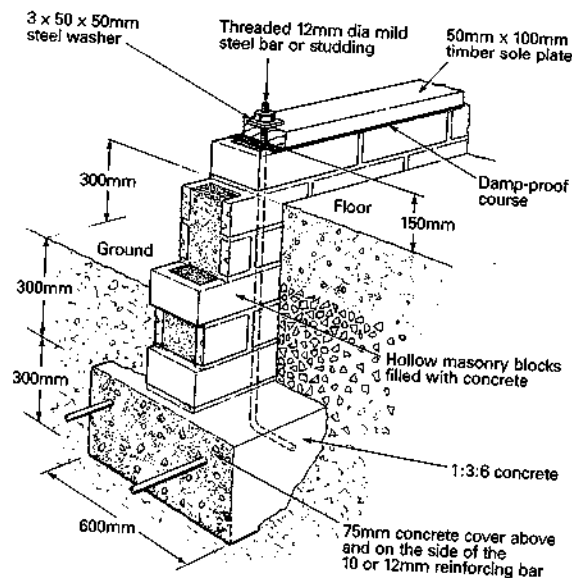
Reinforcing bars should be positioned at every corner and intersection between walls, near each side of every door and large window opening and at intermediate positions not more than 1.2 m apart. For timber-panel walls, use foundations similar to those for masonry walls but use 12 mm diameter threaded steel bar instead of reinforcing bars and bolt the timber sole plate down tight to the masonry. These hold-down fixings should be positioned at every corner and intersection between walls, near each side of every door and at intermediate positions not more than 600 mm apart.

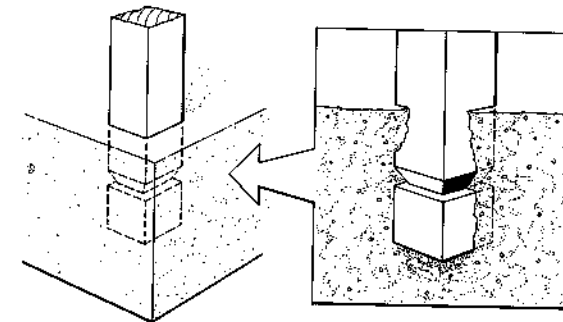
When timber columns are cast in situ in concrete foundations, use timber with good natural durability or treat the foot of the column with preservative. The foot of each column should be notched to a depth of 25 mm to form a key to resist uplift.

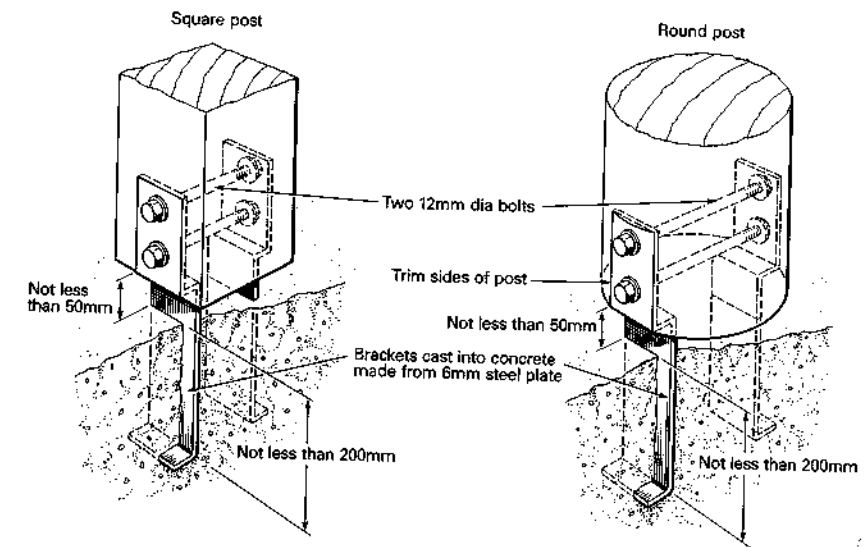
Alternatively, steel brackets can be cast into the concrete to support the foot of each timber column which should be bolted into the brackets with two 12 mm diameter bolts. This method should be used for timber columns with moderate or low durability.

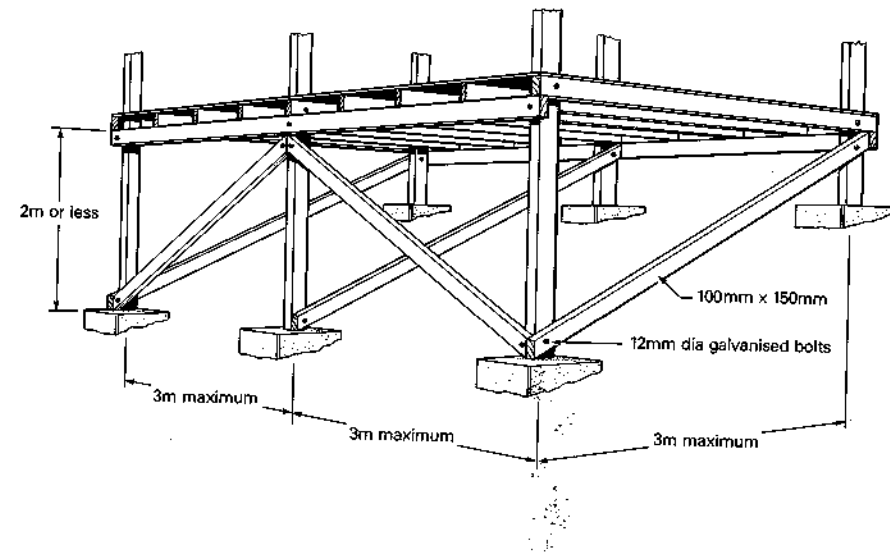
On sloping ground, support the timber floor on braced timber columns set in concrete in the ground. The spacing of the columns should be 3 m or less and the height of any column between the top of the concrete and the underside of the floor joists should be not more than 2 m.

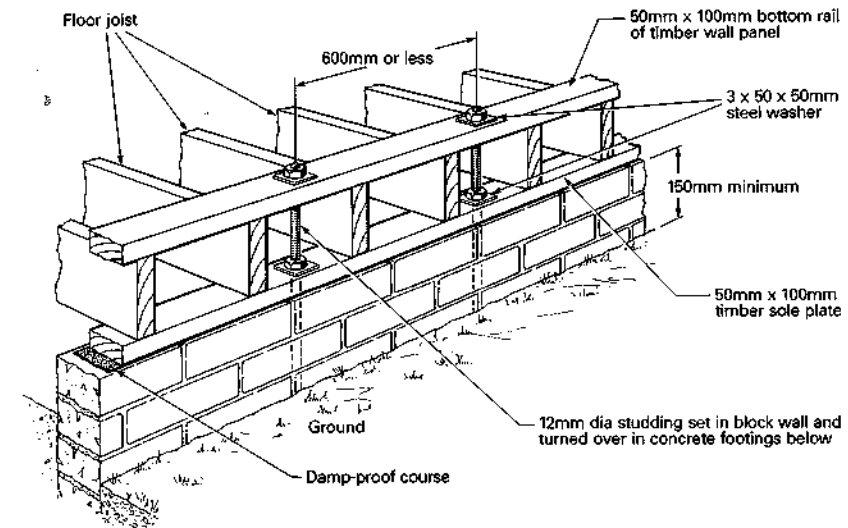
- (1) bolting down the bottom rail of the timber wall panel on top of the joists, with studding cast into the concrete footings, or —

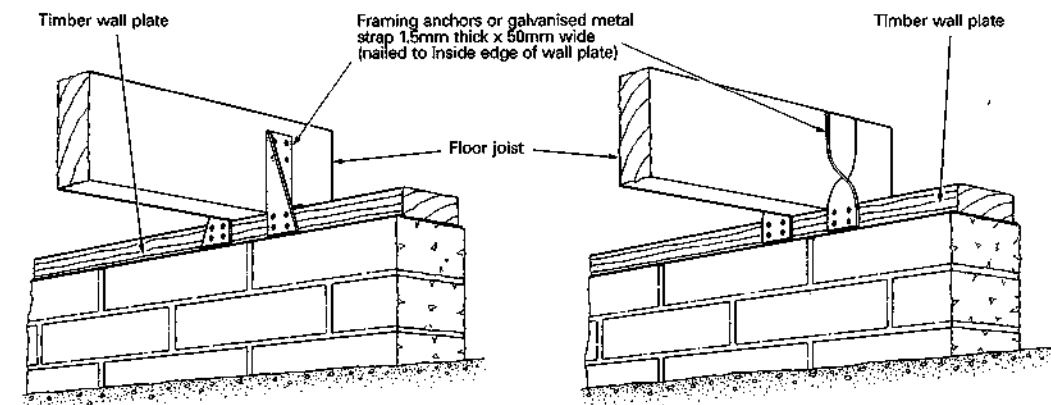
- (2) by fixing to the wall plate with metal framing anchors or galvanised metal straps.

NOTE: Make sure the wall plate is firmly fixed to the foundations.

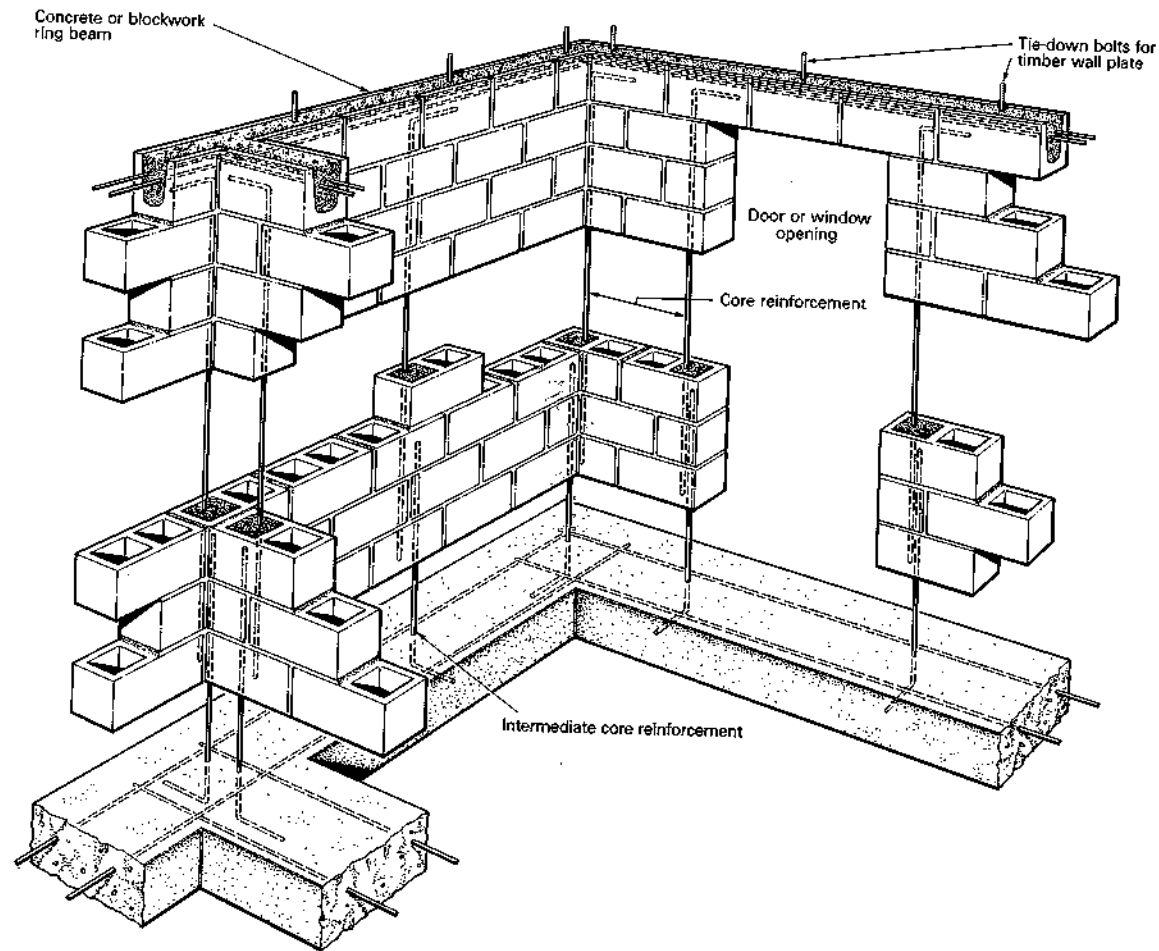
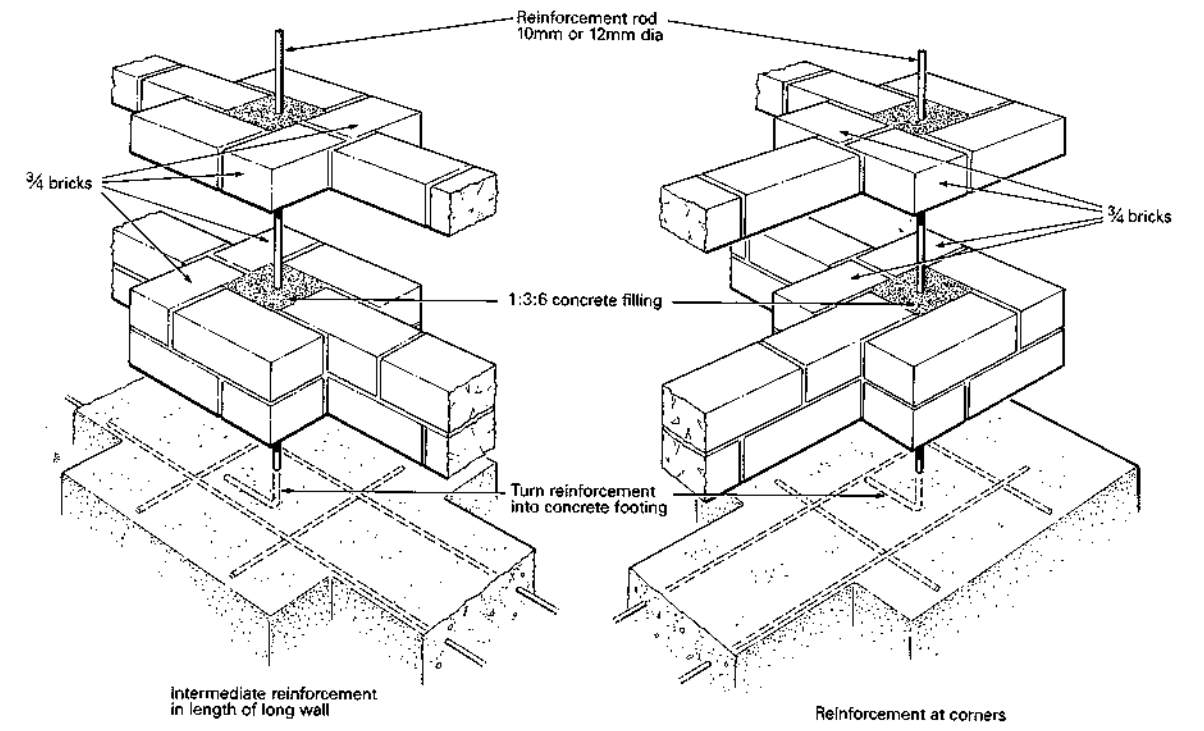
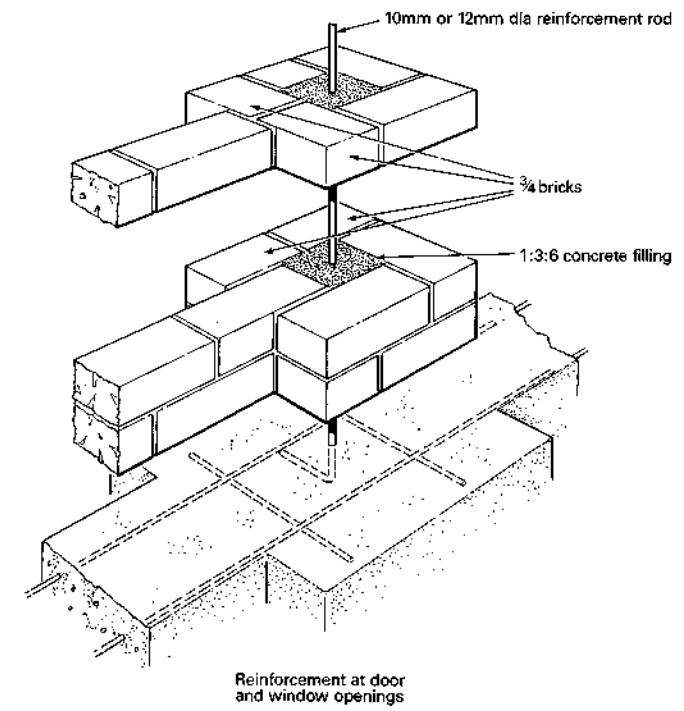
Walls. All masonry walls must be reinforced at all corners and junctions as well as at the sides of the doors and window openings. On long walls without junctions or openings, reinforced sections should be constructed at intervals of not more than 1.2 m for hollow block walls and not more than 2.0 m for solid block walls.

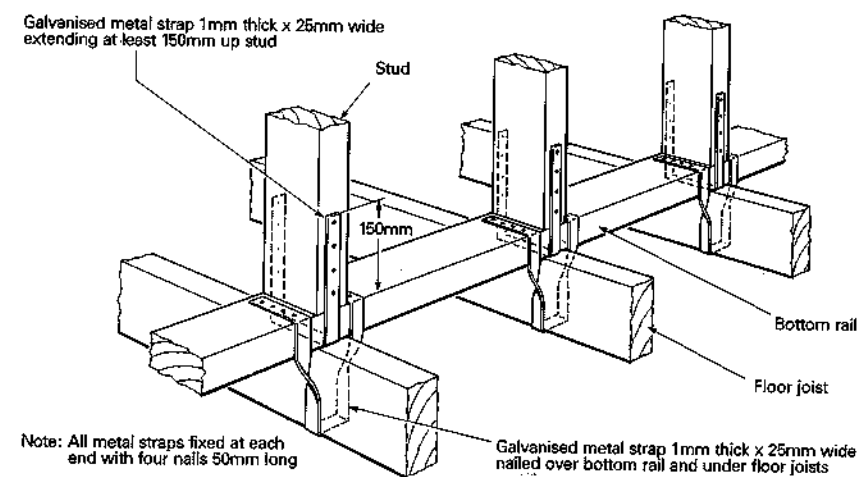
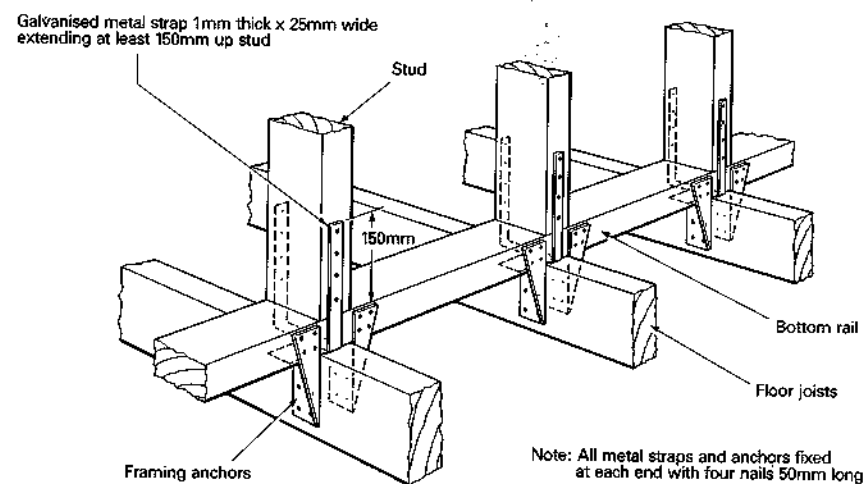
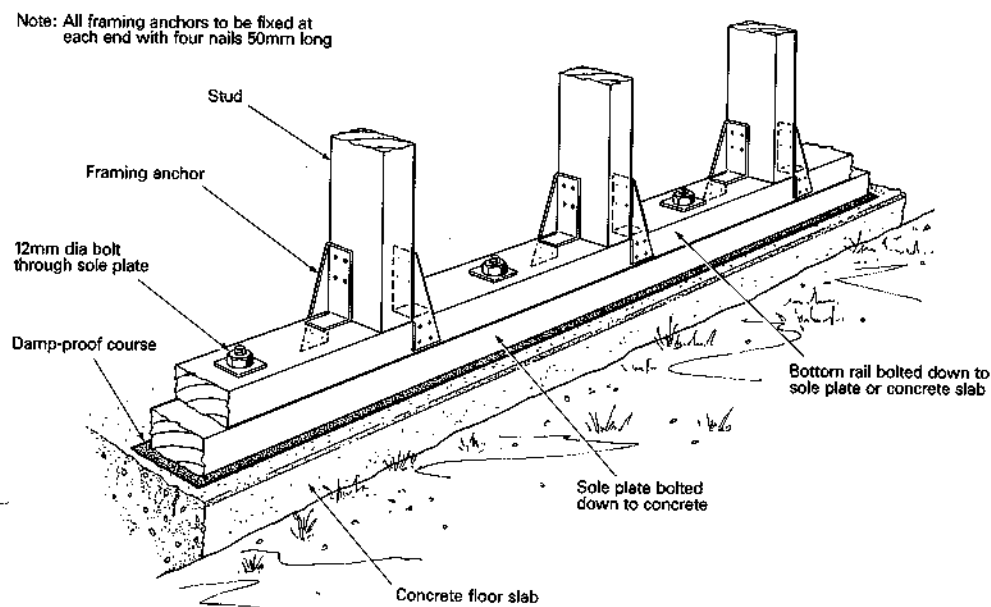
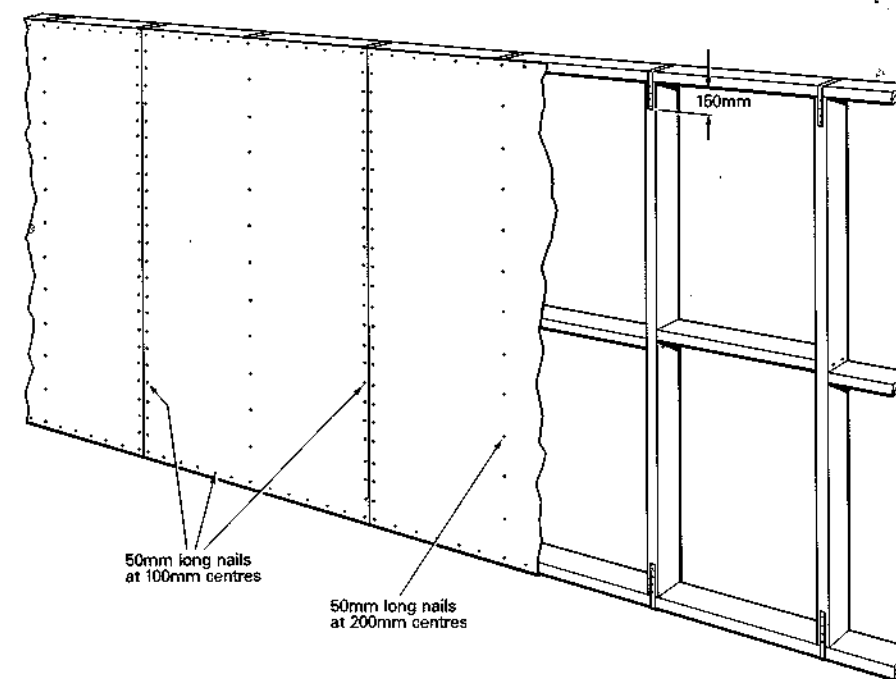
For timber-framed walls, ensure that the bottom rail of every wall panel is securely fixed down to the floor joists, sole plate or concrete foundation with galvanised metal straps, framing anchors or bolts. In addition reinforce every joint in each wall panel frame with metal strapping.

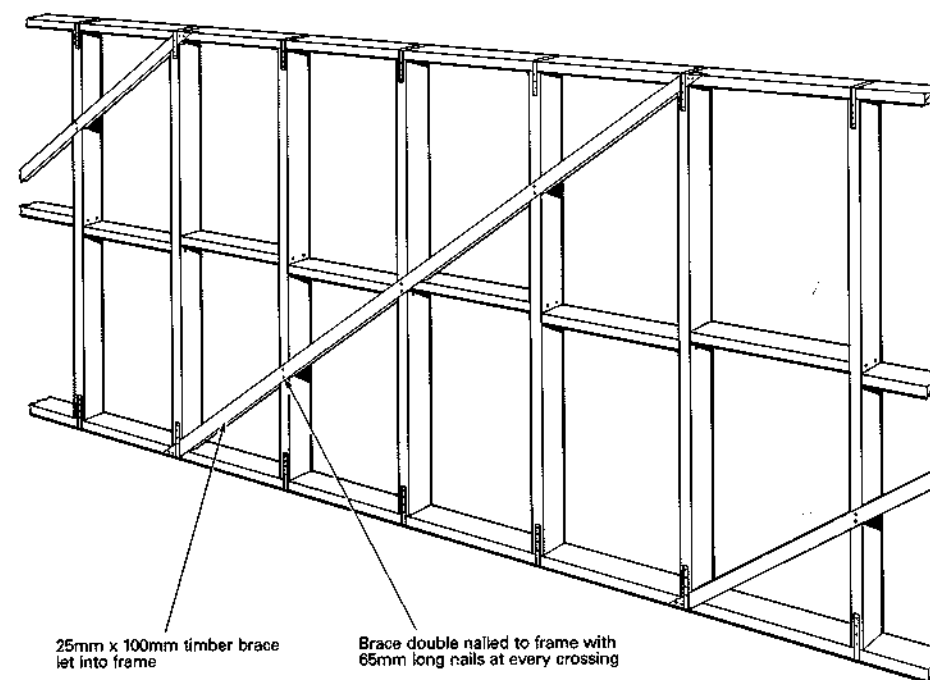
Unless timber-framed walls are fully sheathed with well nailed rigid boarding such as plywood or similar, they should be fitted with diagonal timber braces let into the framing.

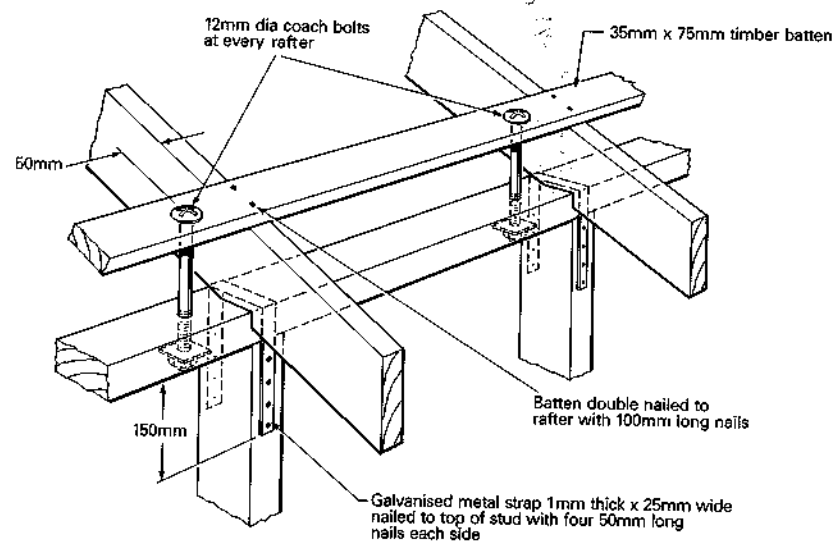
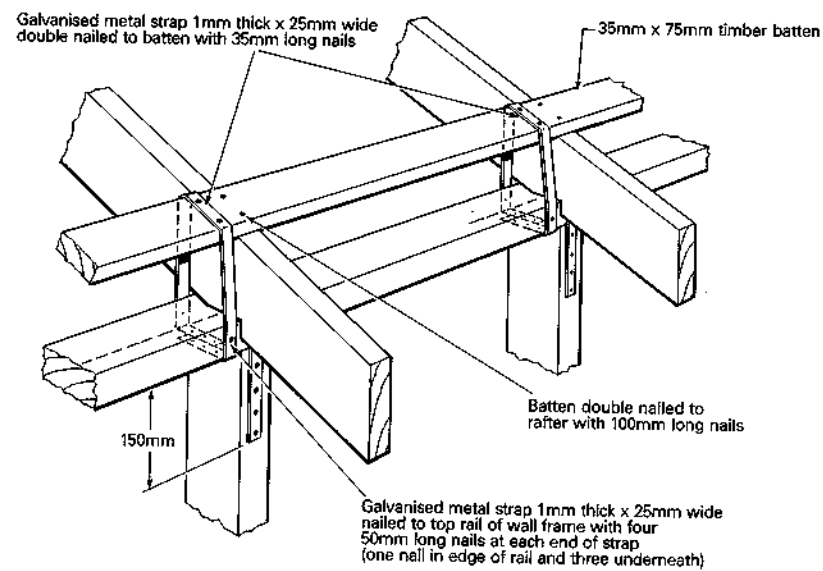
Rafter to timber frame wall connections

Roof. It is essential that all the structural members in a roof, eg rafters, ridge board and purlins, are securely fixed together with metal straps or timber braces. Particular attention should be paid to the arrangement of fixings to ensure that they can adequately withstand large uplift forces on the roof.

For the same reason, the whole roof structure must be firmly tied down to the timber frame or masonry walls with metal straps or bolts and diagonal timber braces should be nailed to the undersides of the rafters at each end of the roof to prevent sideways movement.

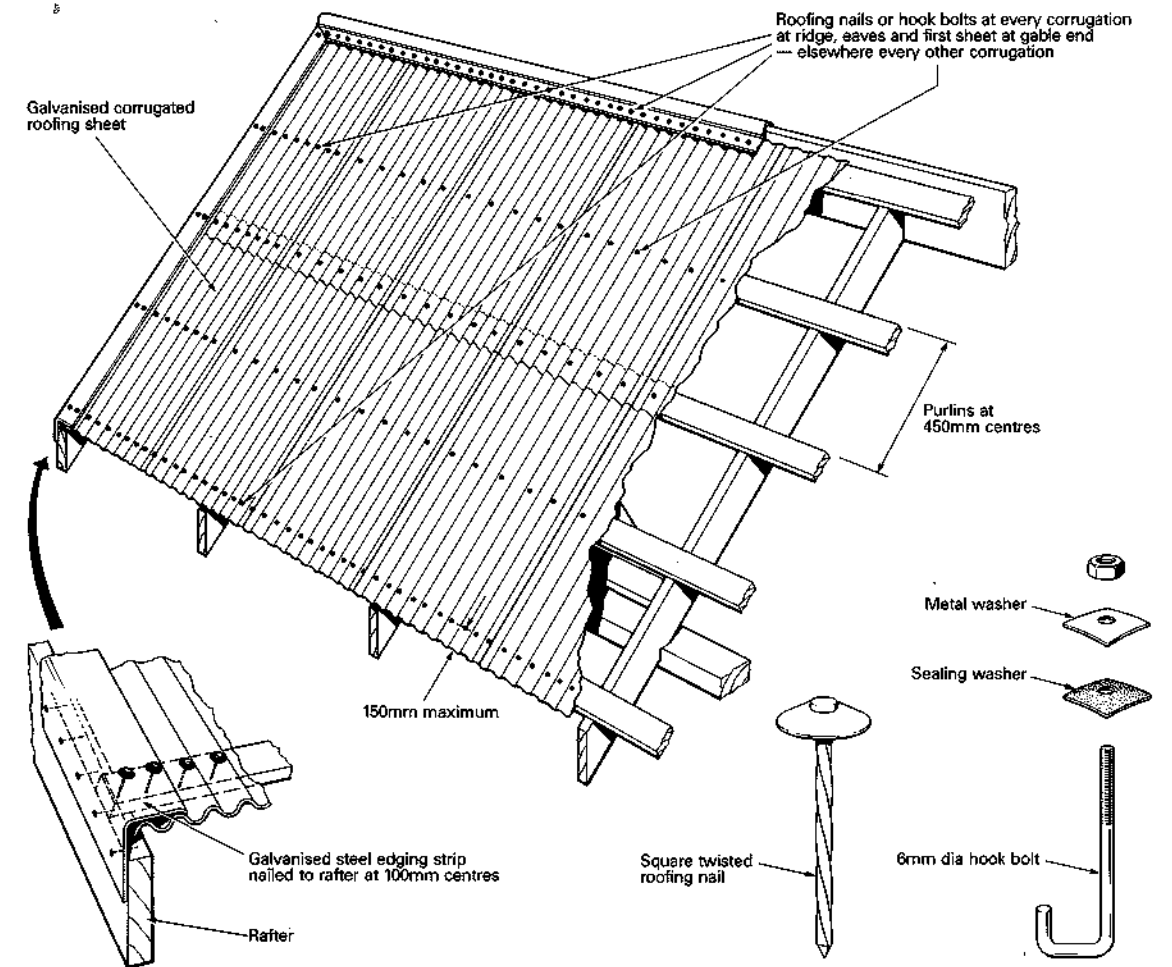
Where lightweight corrugated roofing sheets are used to cover a roof, every sheet should be securely fixed down to the purlins with galvanised hook bolts or special square twisted roofing nails. Particular attention should be given to the edges of a roof where wind uplift forces are greatest and fixings should be more frequent to prevent roofing sheets being 'peeled back'.
