*Urban growth and landslide risk in Tijuana, Mexico*

Aldo Onel Oliva González, Grupo ITEICO Euroamericano / UDCI  
David Mascareño Jiménez, GEOCIM  
Romel Jesús Gallardo Amaya, UFPSO  
Marco Antonio Berumen Rodríguez, GEOSERVICIOS

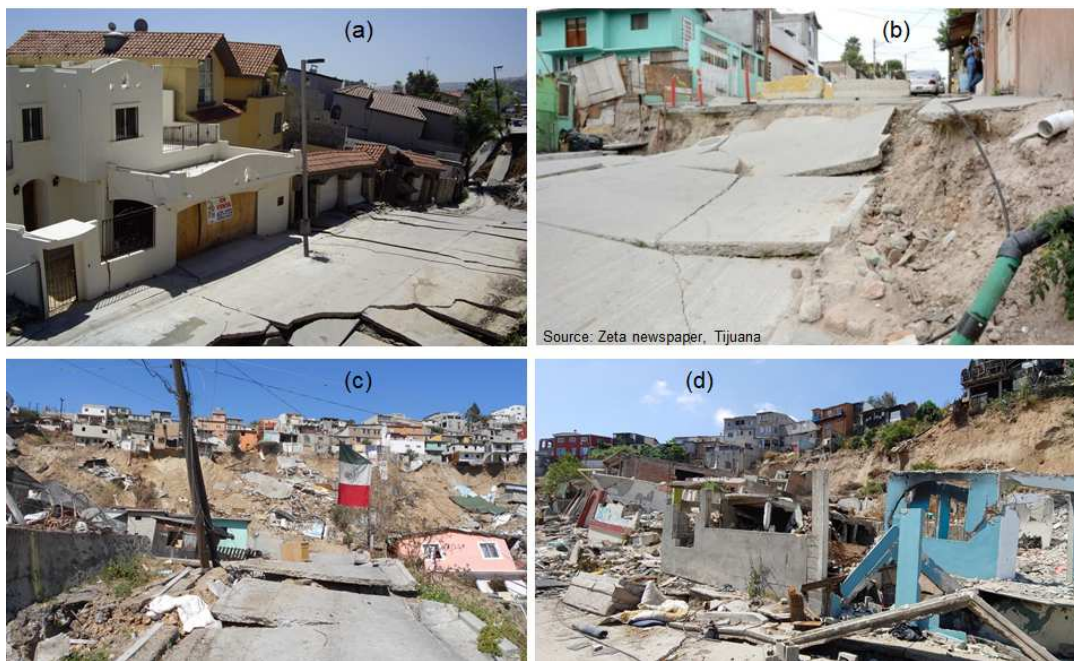
Fig. 1 Some landslides occurred in Tijuana urban area. (a) Landslide in the Laderas de Monterrey neighborhood, 2010; (b) Landslide in the Sánchez Taboada neighborhood, 2016; (c) Landslide in the Liberal Lomas del Rubí neighborhood, 2018; (d) Landslide in the Cumbres del Rubí neighborhood, 2020.

On average, more than two landslides per year occur in the Tijuana urban area, producing direct and indirect negative impacts on physical assets, vital lines, and people; and generating chaos, suffering, and helplessness in the affected communities, as well as considerable material losses in various economic sectors. Due to their frequency and magnitude, these events generate emergencies, the management of which by the authorities is increasingly difficult, and have adverse effects on the socio-economic structure of the municipality (Fig. 1).

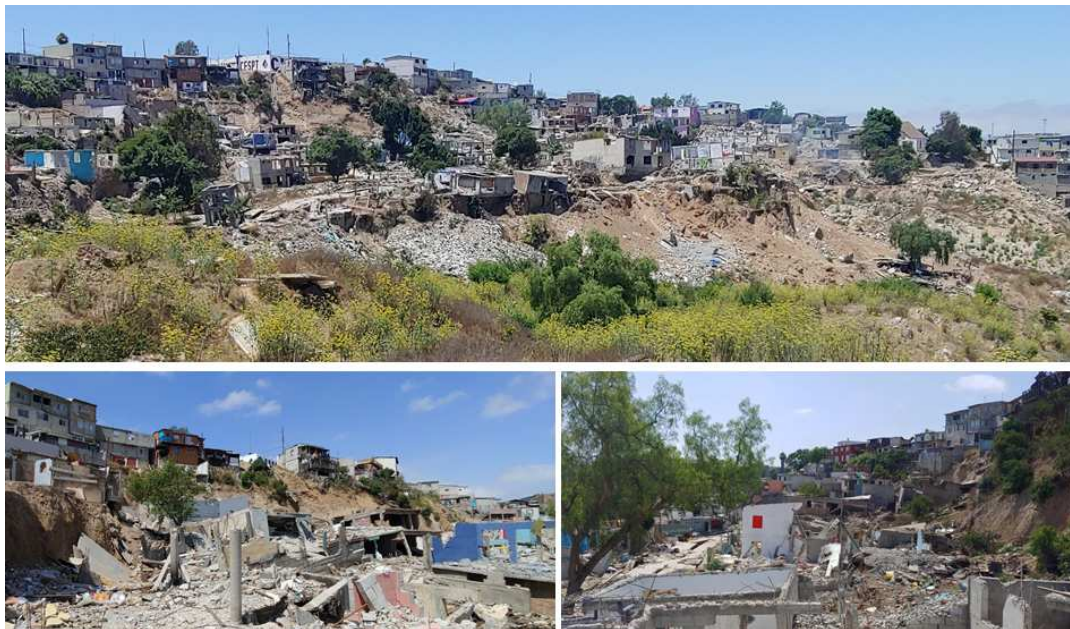
Fig. 2. Area affected by a landslide that continues to be active.

Although the number of landslides was slightly lower in the last decade, the magnitude and intensity of the events and their impacts on urban structures and infrastructures experienced significant growth between May 2010 and October 2020. Four of the landslides that occurred in this period affected approximately 70 hectares of the urban area and destroyed more than 680 homes. Currently, these landslides are active and the unstable land masses continue to move, putting the property and lives of many people at risk (Fig. 2).
