IMPROVEMENT OF LOW-COST HOUSING IN FIJI
TO WITHSTAND HURRICANES AND EARTHQUAKES

INTERTECT

April 1982

Study and recommendations prepared for
the Office of U.S. Foreign Disaster Assistance,
Agency for International Development
Washington, D.C. 20523

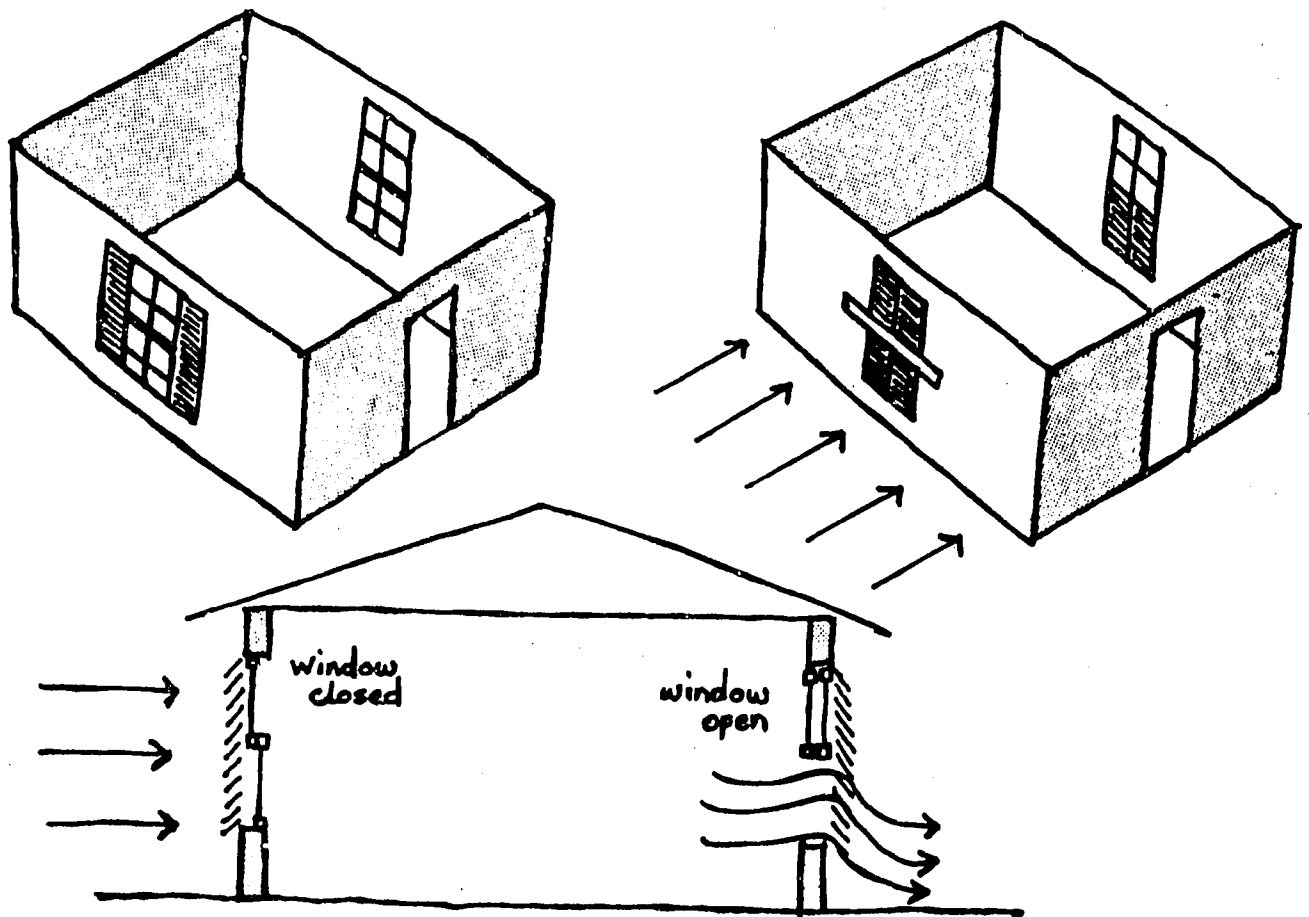
When placed over a relatively airtight window, storm shutters are an ideal adaptation to a hurricane environment. The drawing below illustrates the principles behind their use. When a hurricane threatens, the storm shutter is closed over the window. The shutter protects the opening from flying debris and the downward angle of the panels prevents rain from entering the window.

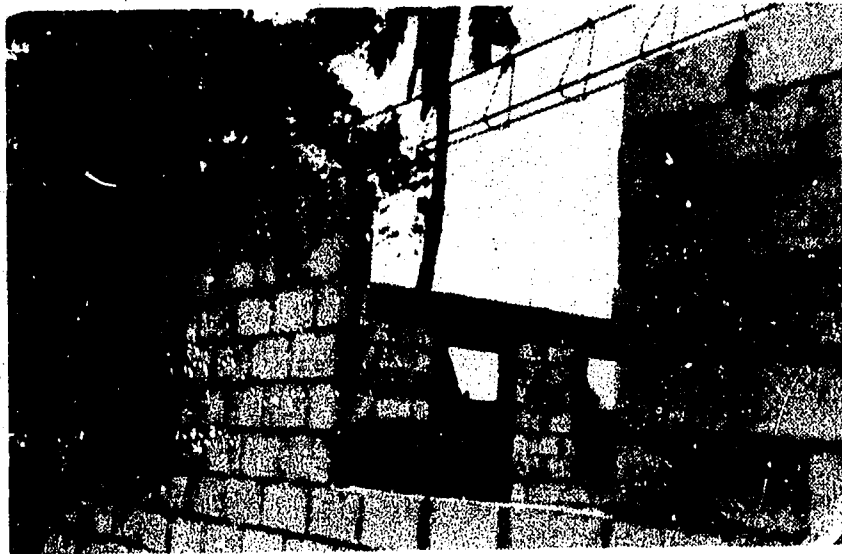
5. Poor connections between interior and exterior walls.
6. Unlevel masonry on each course.
7. Insufficient reinforcement in poured columns, and insufficient use of rebar placed inside block walls.
8. Poor detailing around doors and windows.
9. Improper or insufficient foundations.
10. Excessive spans and questionable detailing of lintels above windows.

NOTE: The problems of poor detailing are common to both owner-built and contractor-built houses, but problems of insufficient or poor-quality reinforcement reportedly appear more in contractor-built housing and represent attempts to cut costs. This is a problem that can only be addressed through expanded and stricter code enforcement activities.

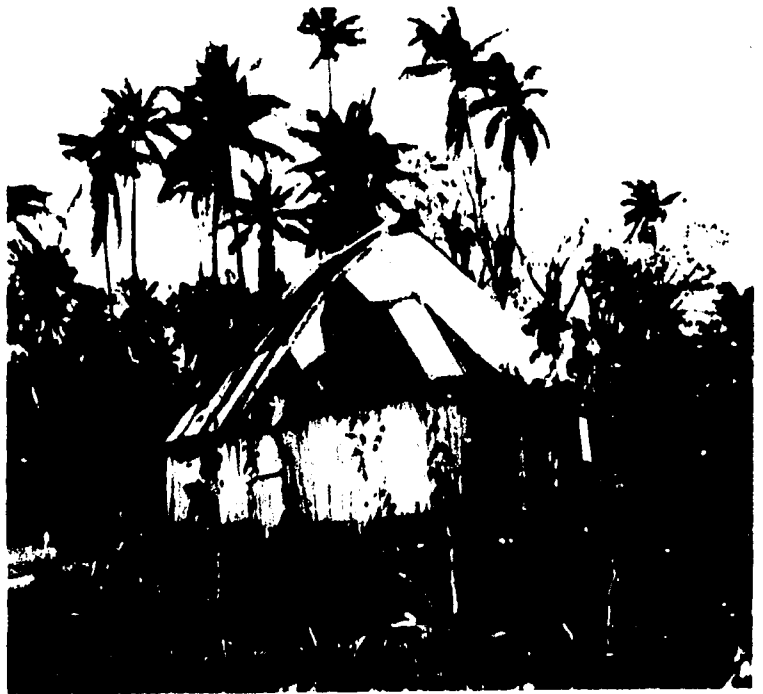
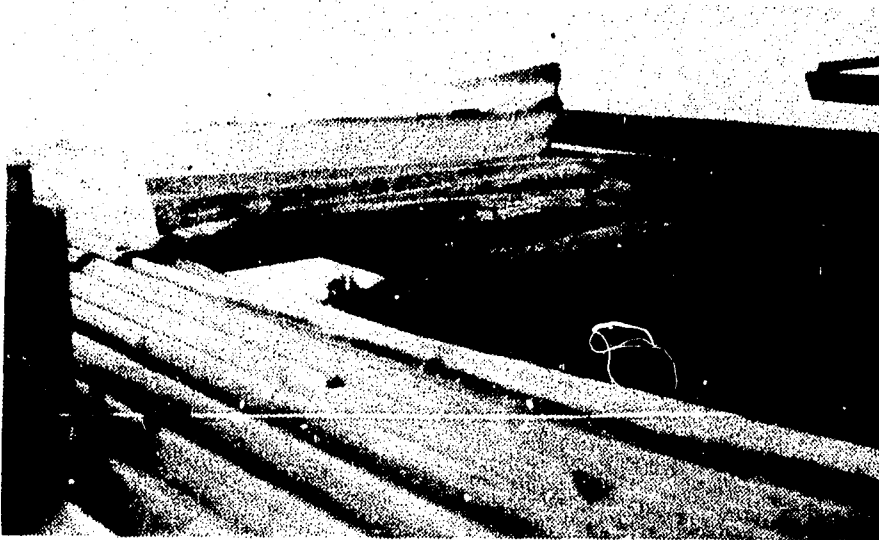
Inadequate Nailing of
Corrugated Iron to Purlins
